# Impacts of Fuel Releases from the CEI Hub Due to a Cascadia Subduction Zone Earthquake

EXECUTIVE SUMMARY

The purpose of this study is to identify the magnitude and extent of potential fossil fuel releases at the CEI Hub from a CSZ earthquake and to evaluate the resulting damages. ECONorthwest, Salus Resilience, and Enduring Econometrics prepared this report for the City of Portland and Multnomah County. For more information about this report, contact: Laura Marshall, Project Manager at marshall@econw.com.

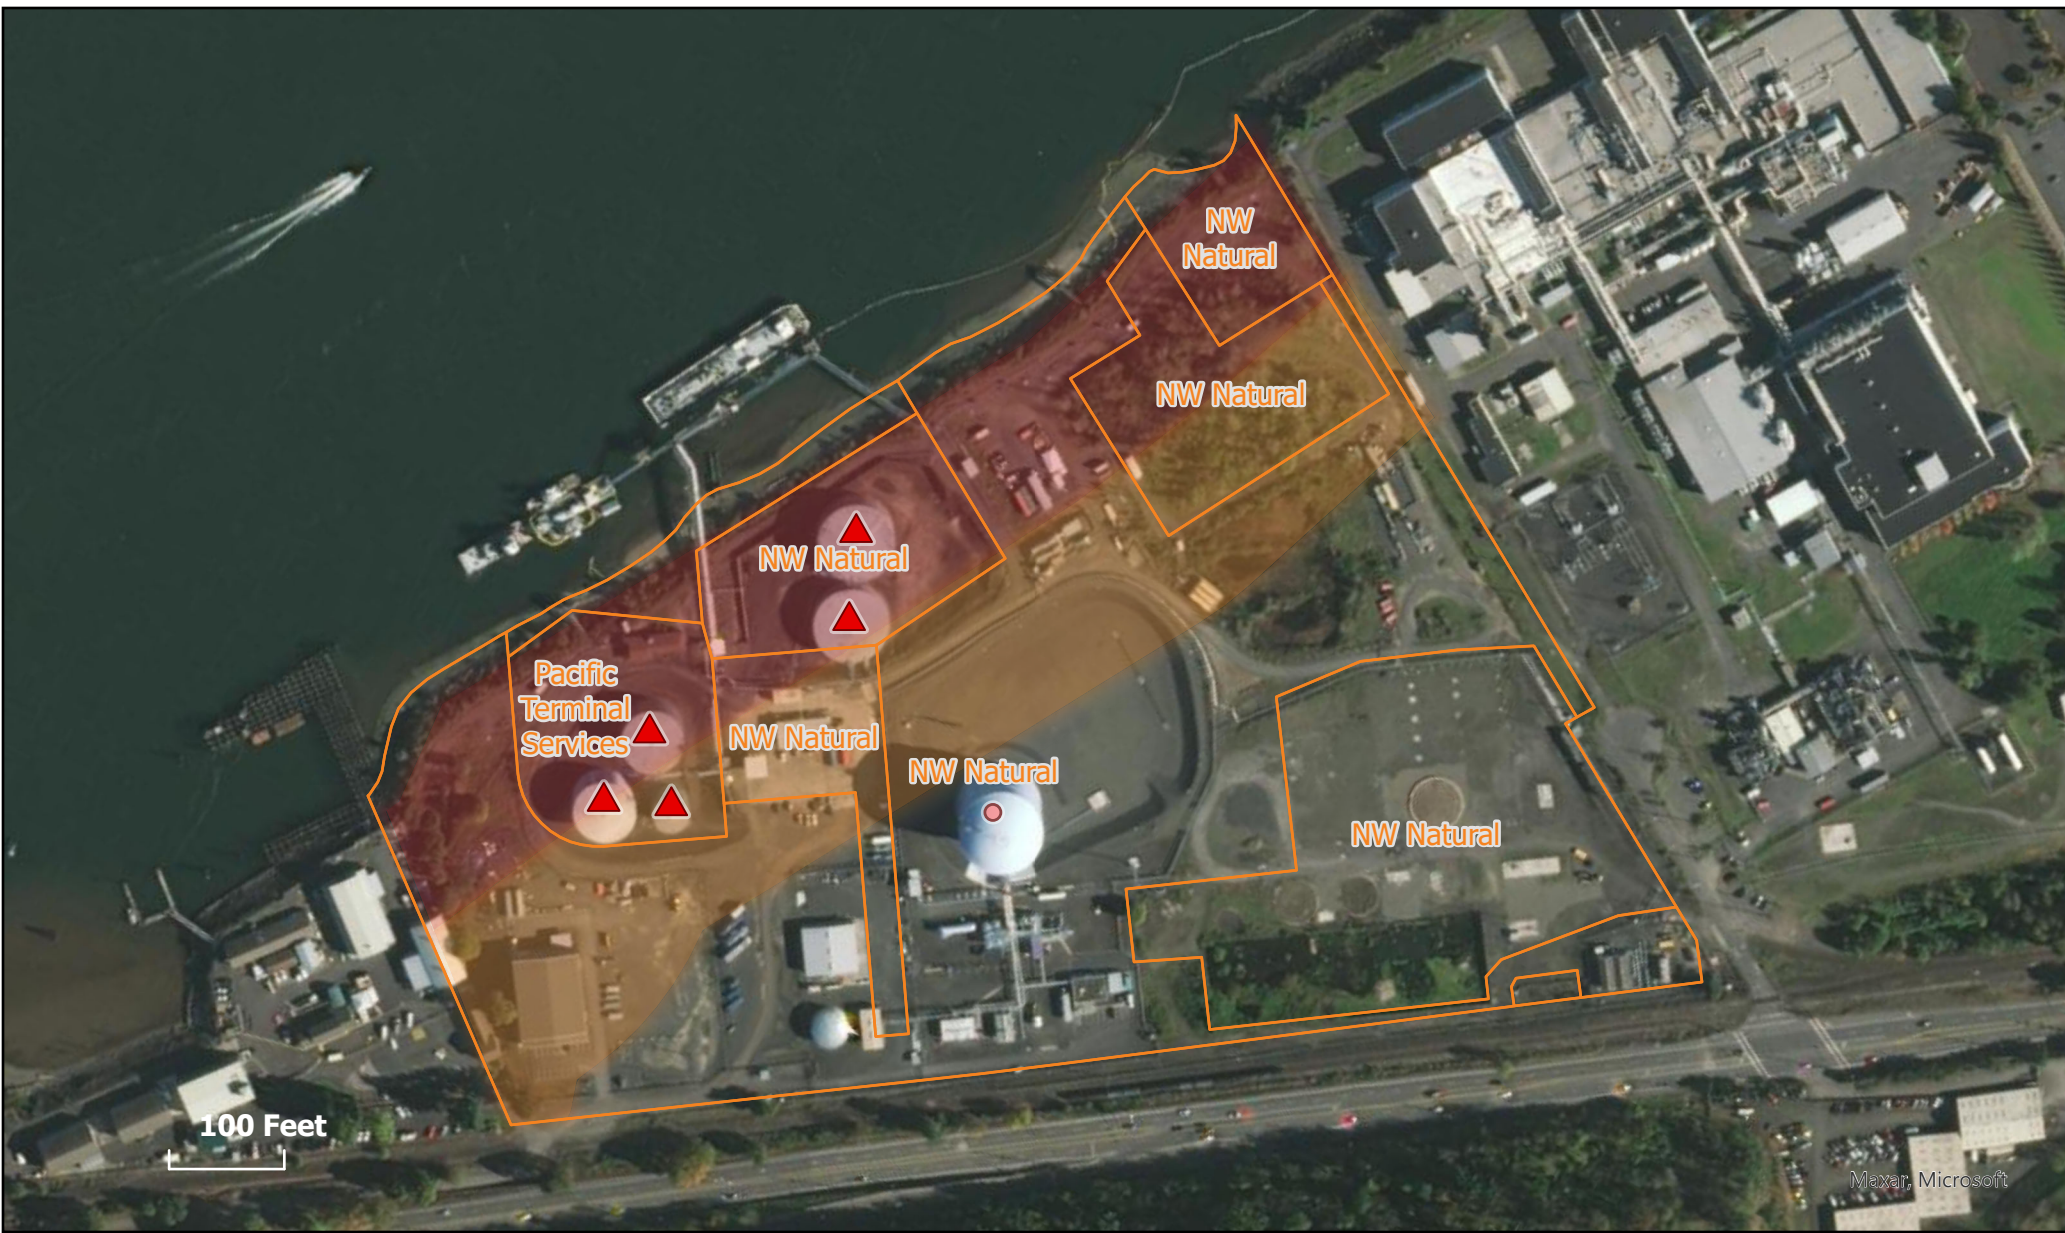
**FIGURE 2C**  
**NW NATURAL**

**Tank Release**

▲ Flammable and Hazardous

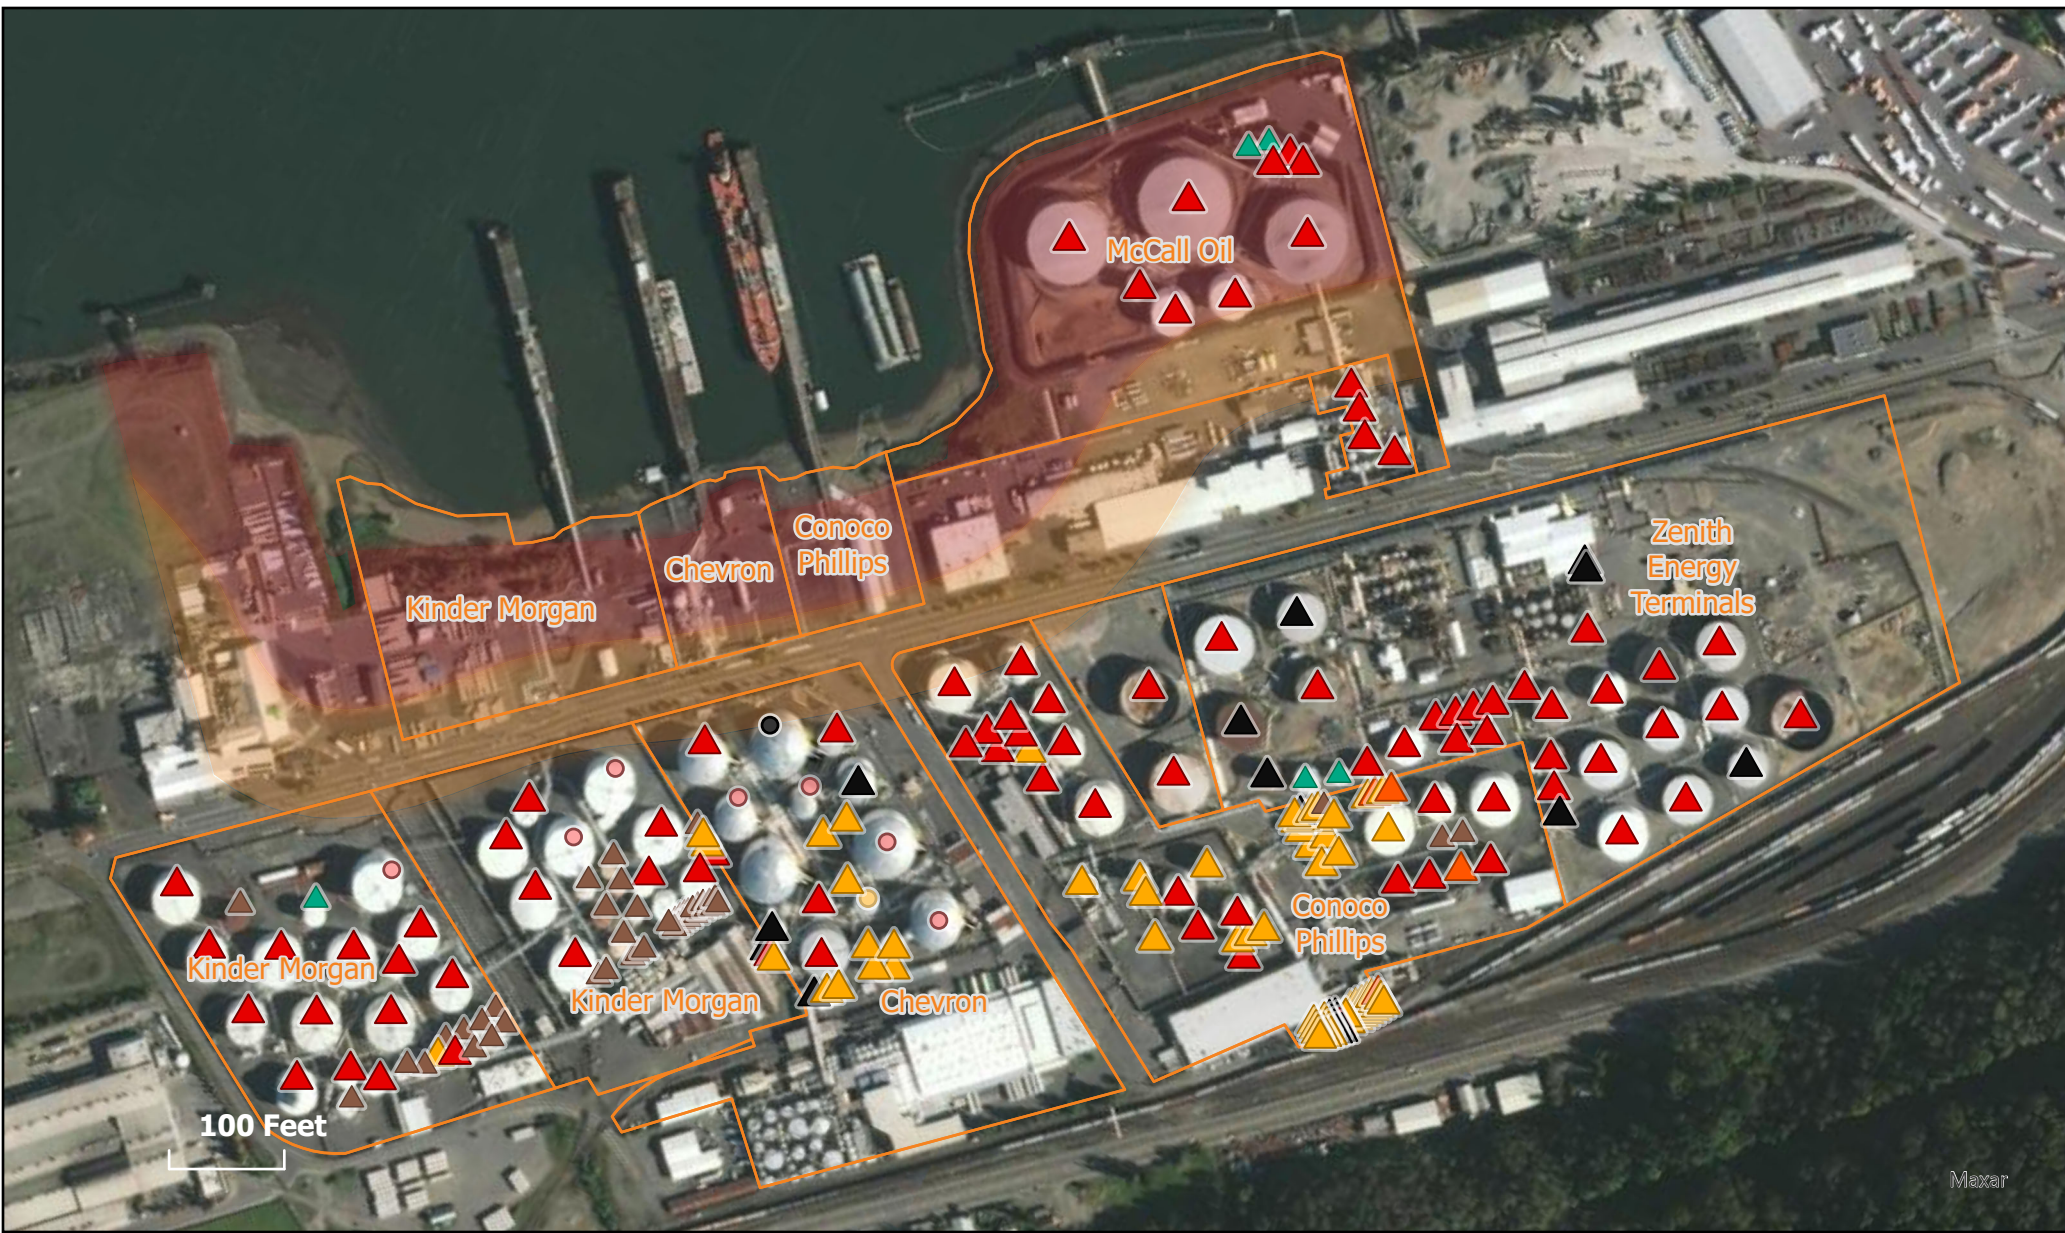
**FIGURE 2D**  
**WILLBRIDGE**

**Tank Release**

- ▲ Flammable and Hazardous
- ▲ Flammable (but not Hazardous)
- ▲ Hazardous (but not Flammable)
- ▲ No Data

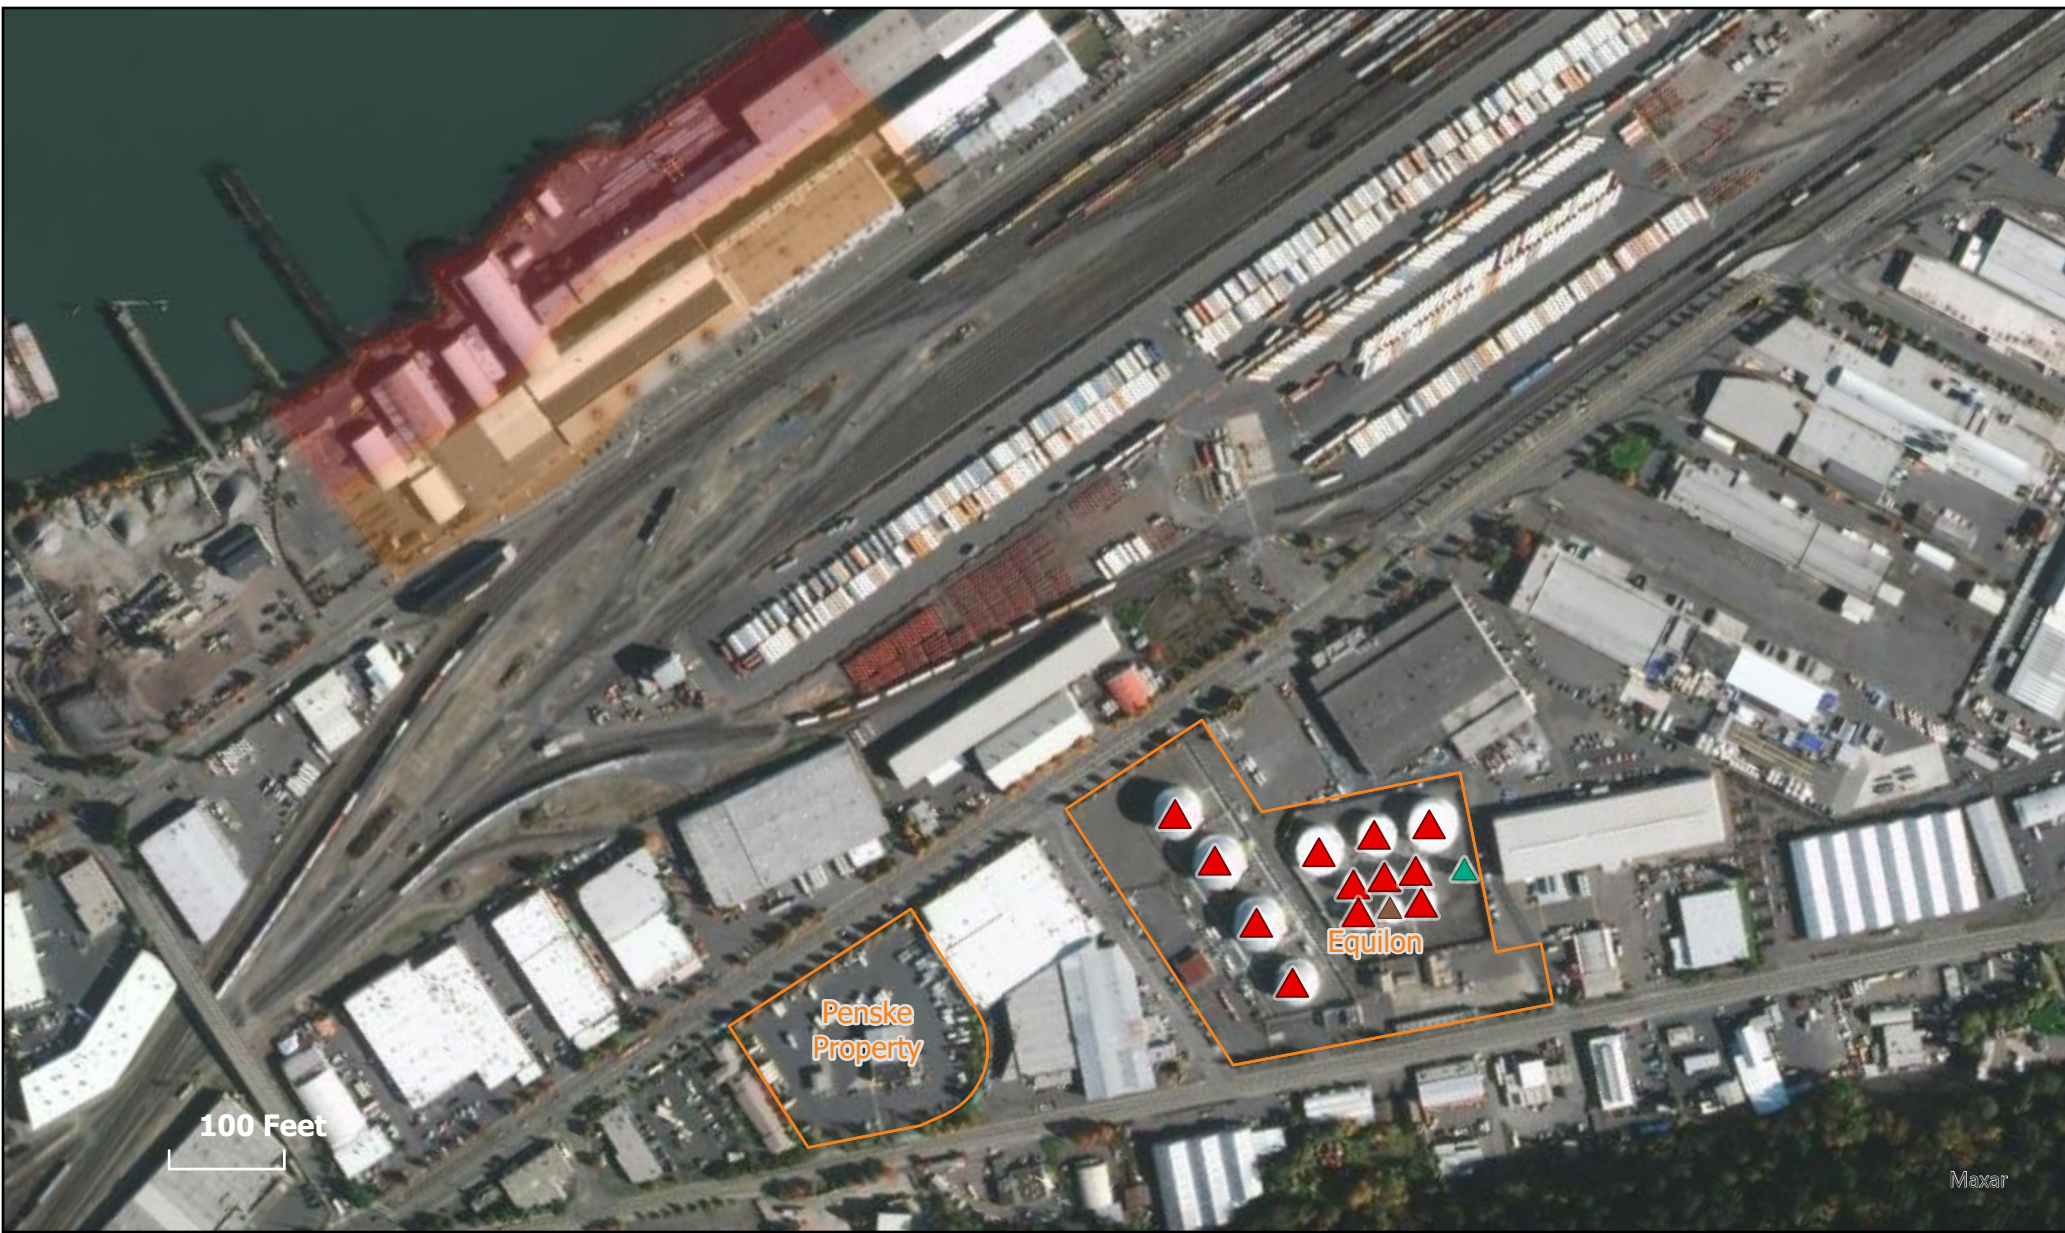
**FIGURE 2E  
EQUILON**

**Tank Release**

- ▲ Flammable and Hazardous
- ▲ Empty or Out of Service
- ▲ Tank Failure, not Flammable and not Hazardous
- Taxlot Boundary
