City of Portland Historic Landmarks Commission

Design Advice Request

Date: November 21, 2022
To: Jeff Hawthorne, City of Portland, OMF
From: Hillary Adam, Design & Historic Review Team
503-823-8953 | hillary.adam@portlandoregon.gov
Re: EA 22-188130 DAR – Thompson Elk Fountain
Design Advice Request Commission Summary Memo – November 7, 2022

Thompson Elk Fountain Reinstallation
Design Advice Request

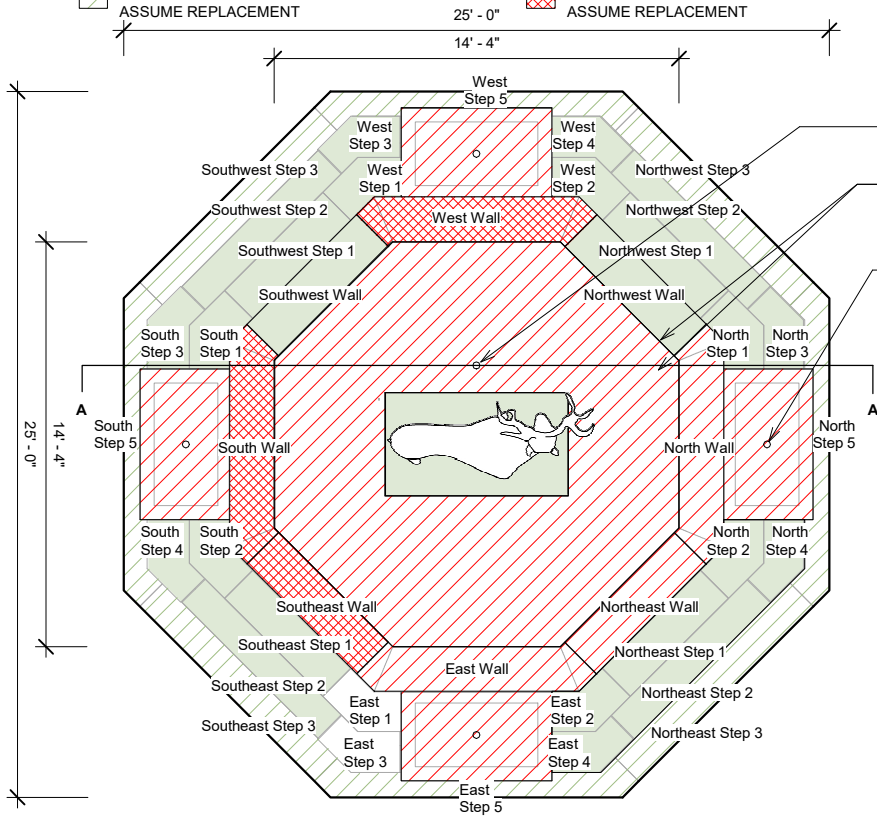
(A) Fountain Plan
1/4" = 1'-0"

PROVIDE DRAIN IN BASE FOR EMPTYING / CLEANING

NEW FOOTING, SLAB,
2-PART EPOXY
WATERPROOFING
FROM INSIDE

PROVIDE DRAIN IN EACH
TROUGH FOR WATER
RECIRCULATION

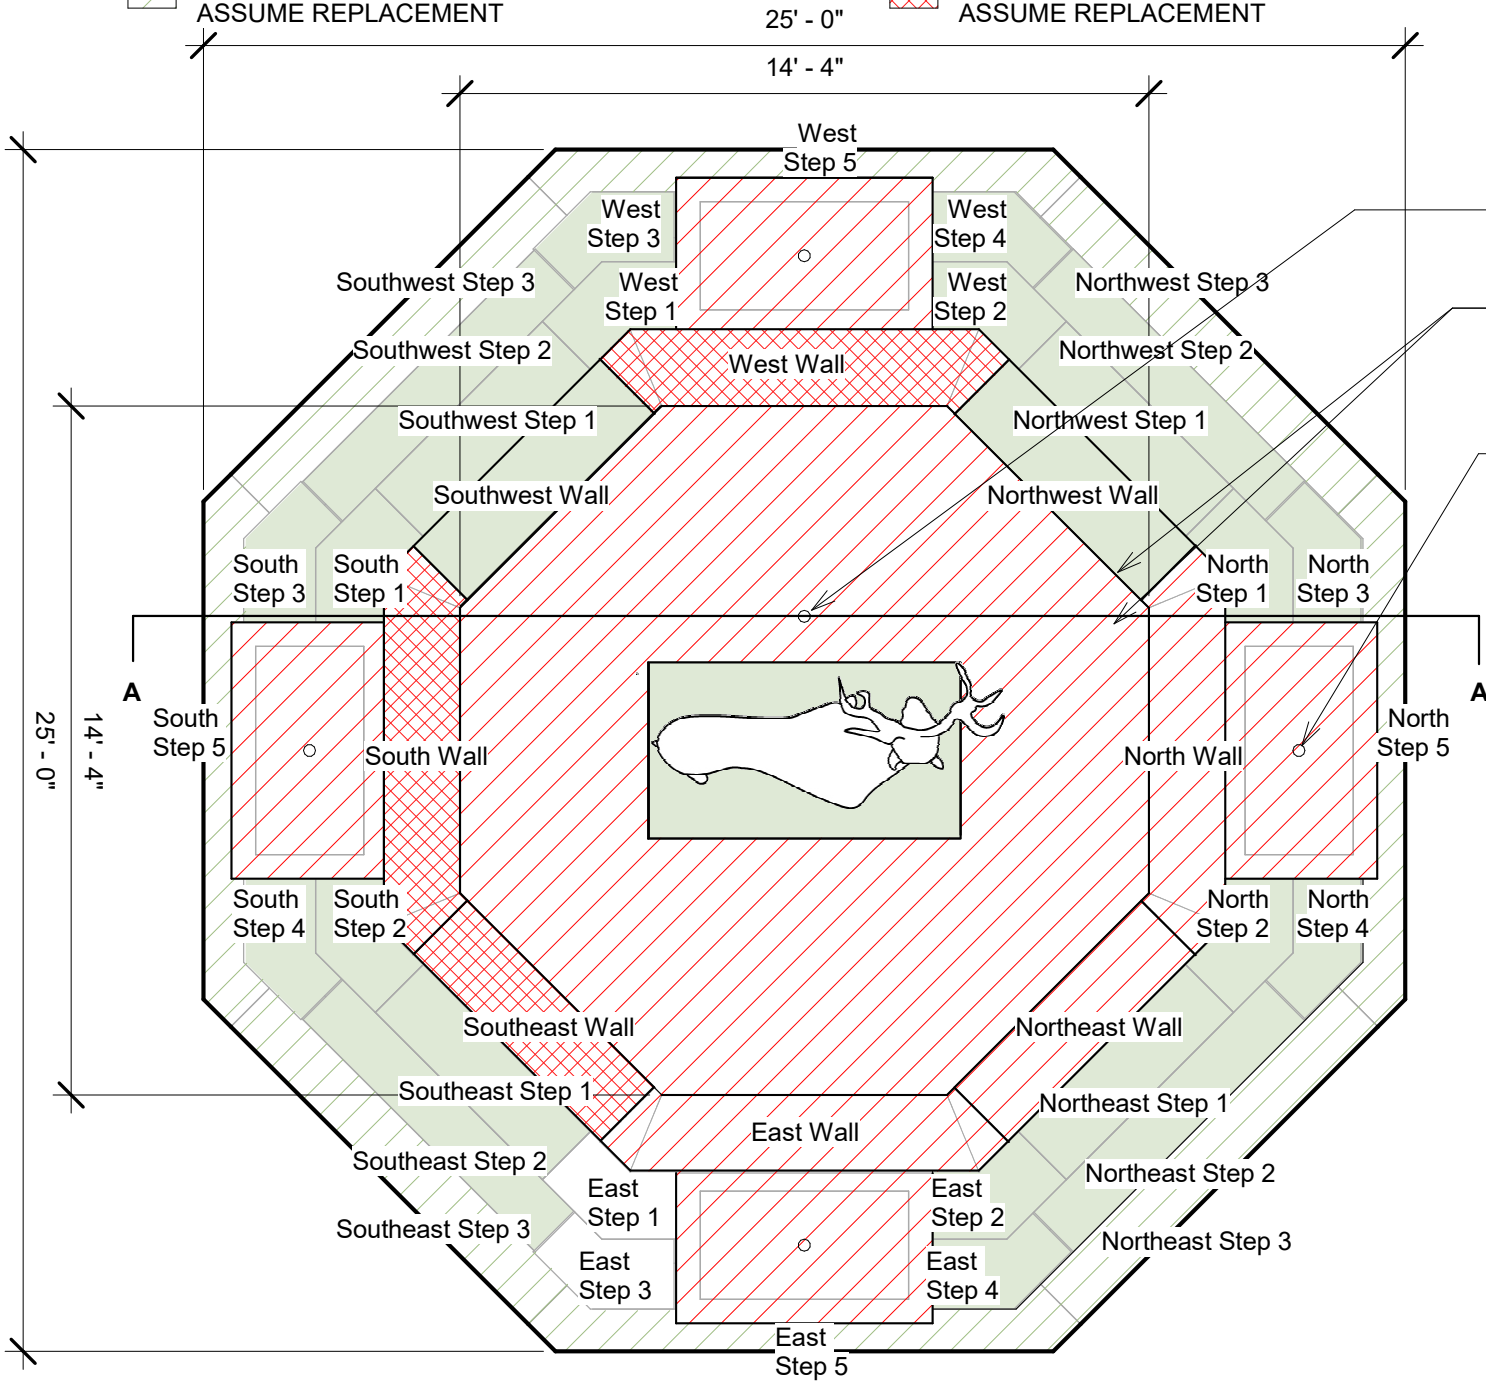
A Fountain Plan
1/4" = 1'-0"

- PROVIDE DRAIN IN BASE FOR EMPTYING / CLEANING
- NEW FOOTING, SLAB, 2-PART EPOXY WATERPROOFING FROM INSIDE
- PROVIDE DRAIN IN EACH TROUGH FOR WATER RECIRCULATION

B Section A-A
1/4" = 1'-0"

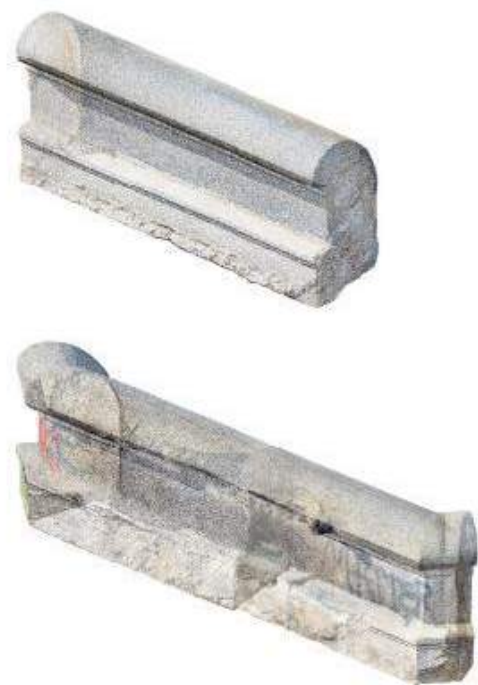
3D Scan of stone pieces using Polycam

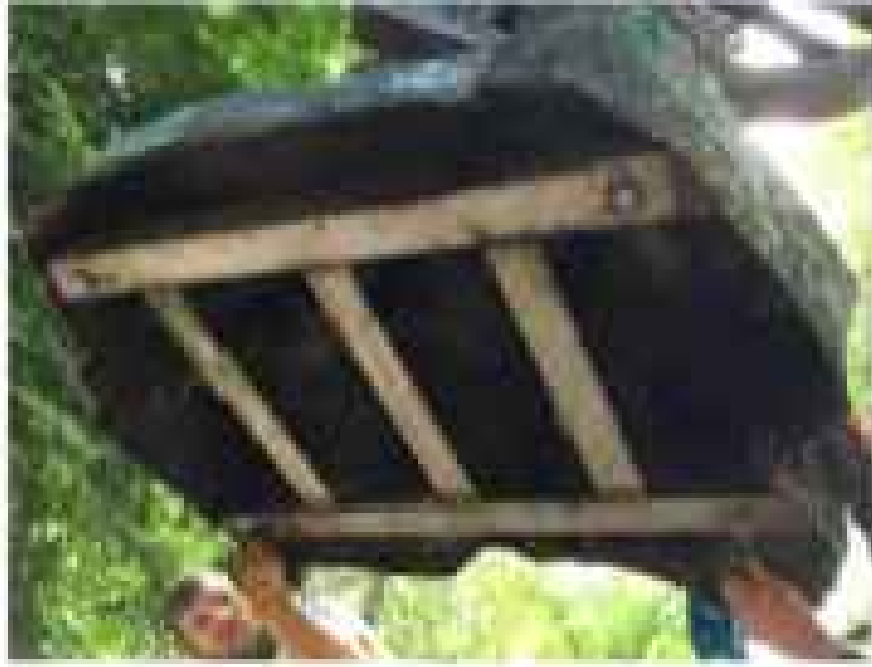
PROVIDE NEW ARMATURE AT ELK FOUNTAIN BASE, CONNECT TO BASE WITH STAINLESS STEEL RODS (ASSUME 4)

NEW PUMP AND VAULT INFORMATION"
