Responses for HLC Hearing #2 on 1/12/15

Thank you for giving us the opportunity to respond to some of the issues raised in the December 1, 2014 land use hearing (LU 14-218444) for the Tabor Reservoir Adjustments. Below are the bureau's responses to the BDS recommended conditions of approval and a few of the key questions raised during the hearing.

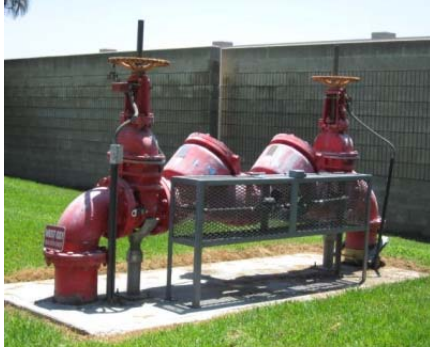
10-inch RP device in California

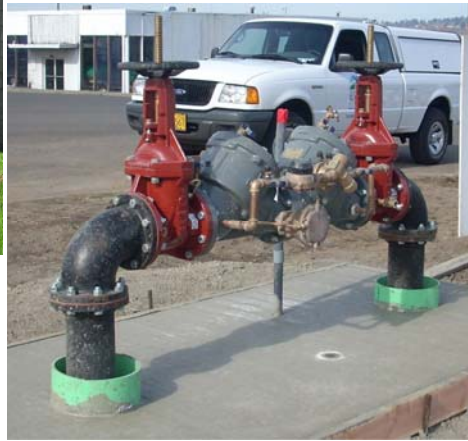
8-inch RP device in Portland
