Staff Presentation to the
Portland Design Commission

Design Review Hearing
LU 15-116838 DZM

818 SE 6th Avenue

May 7, 2015

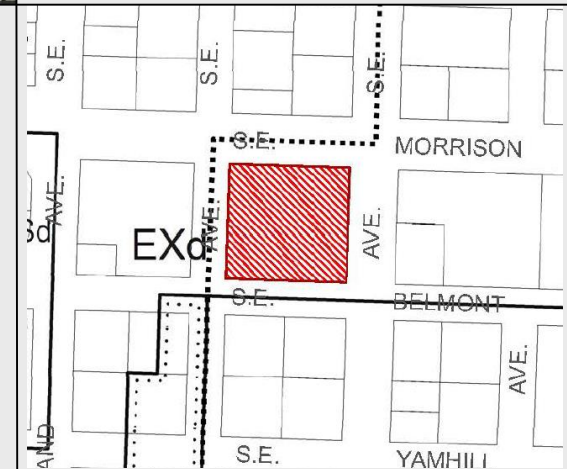
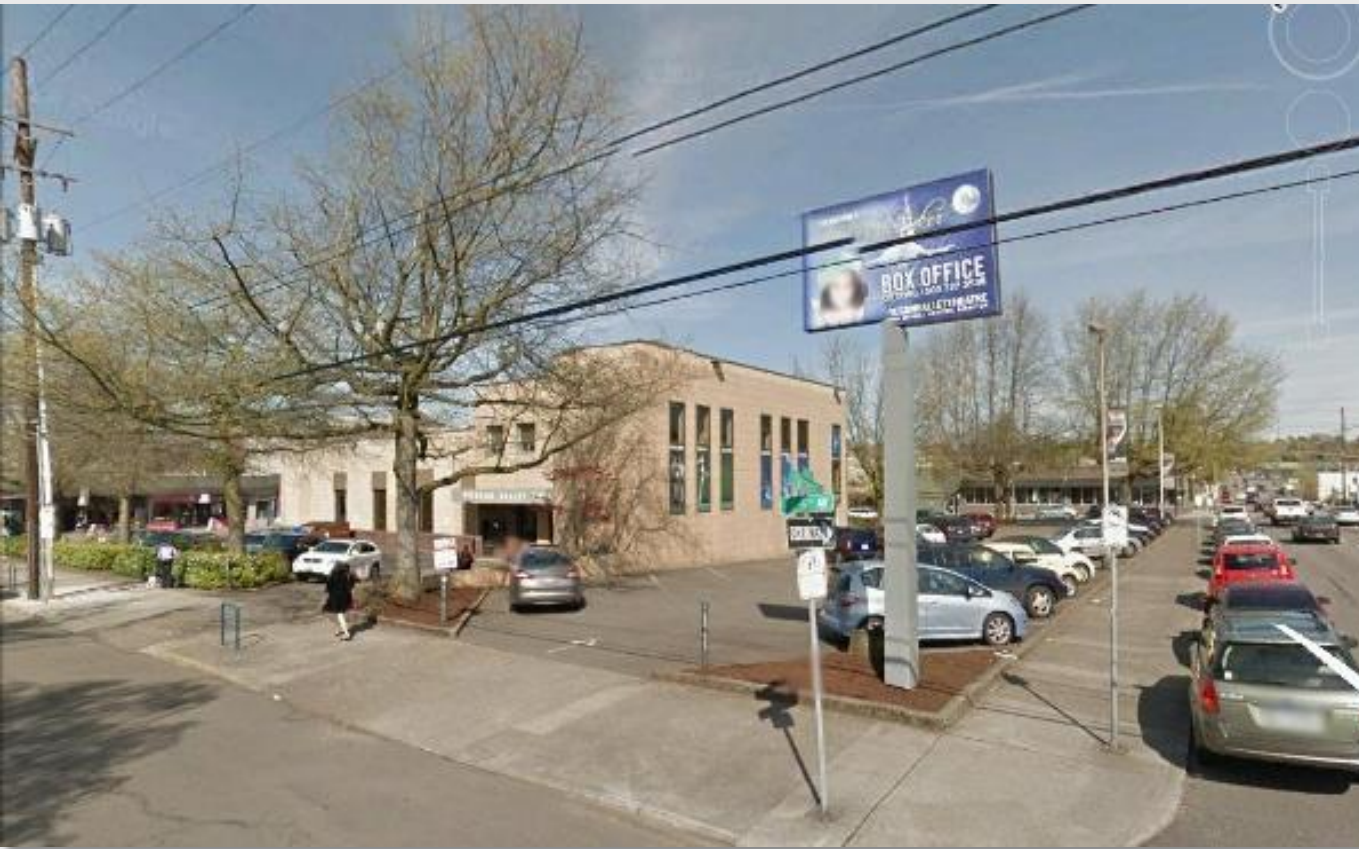
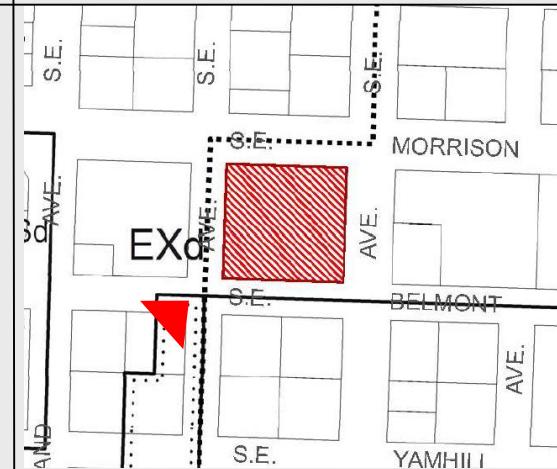
The SITE

Site Location

SE 6th Ave – W
 SE Morrison St – N
 SE 7th Ave – E
 SE Belmont - S

Site Area

37,600 square feet

Site Disposition

Approx. 5' drop NE

Existing Condition

14,146 SF building
 Surface parking
 Drive-thru ATM

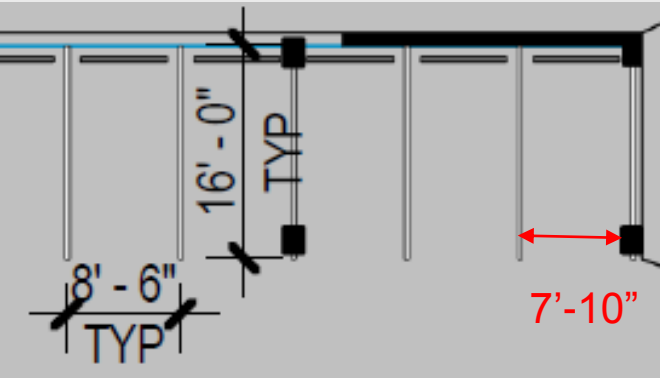
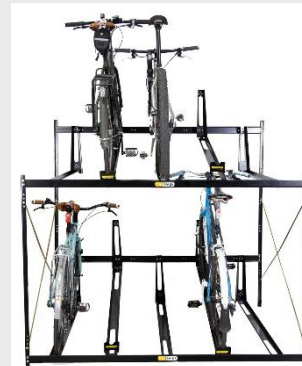
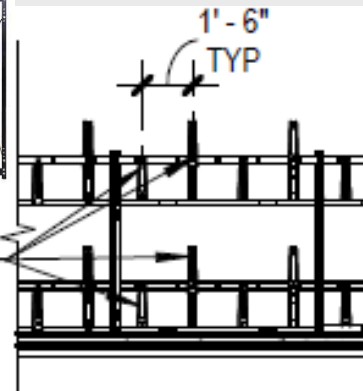
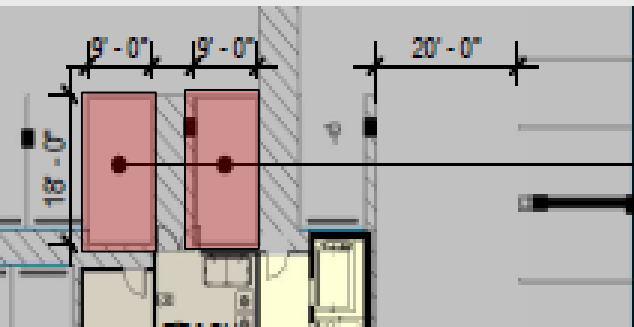
ALTERNATING
HEIGHTS >6"

(2) LOADING SPACES

Reductions to:

- Vehicle parking space width from 8'-6" to 7'-10" – *Staff supportive*
- Bike parking space width from 2' to 18" – *Staff supportive*
- Height of loading space from 10' to 9' – *Staff supportive*

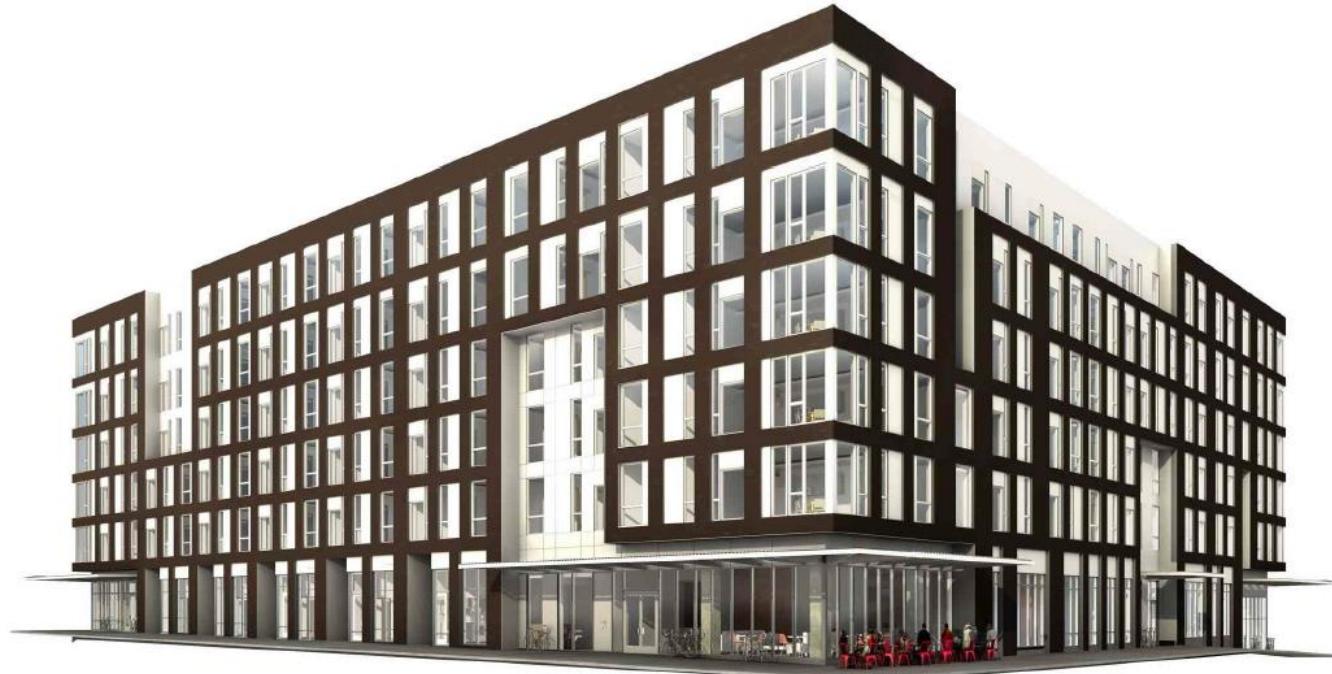
DESIGN ADVICE REQUEST

February 5, 2015

- Skewer concept
- 4 types of metal panel and colors

Feedback from Commission:

- Need for one clear, unified and organized concept (unanimous)
- Support for an entirely brick building
- Concerns with quality of courtyard space (mostly stormwater facility)
- Need for active ground level uses

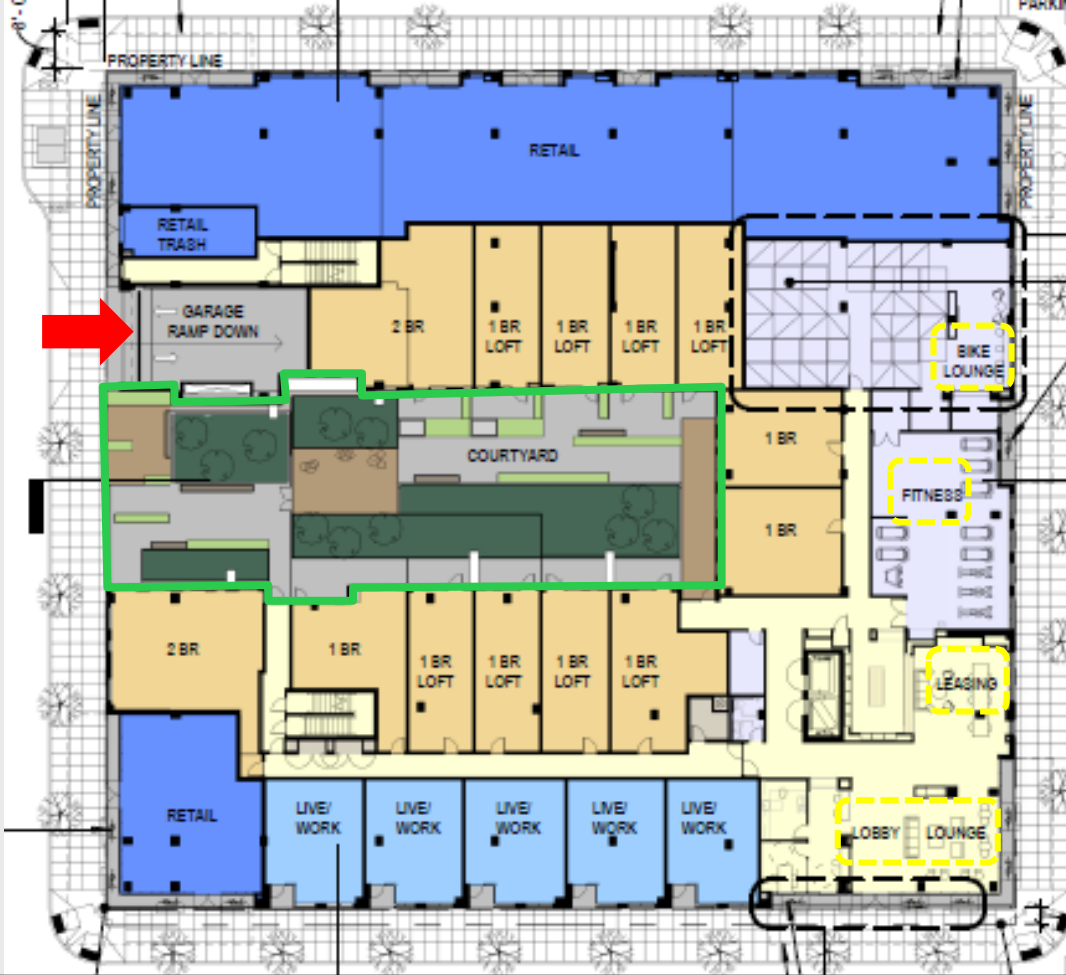
The **PROJECT OVERVIEW**

5 over 1 w/basement garage
mixed use

Height

70 feet to Top-of-Parapet

FAR

4.8:1

Materials

Dark Red Brick

White Metal Panel

Aluminum Storefront

White Vinyl Windows

Residential units 201

Live-work units 5

Retail 7,300 SF

Auto Parking 105 spaces

Bike Parking 312 LT / 13+ ST

Courtyard 5,662 SF

- **Storm H2O** 2,048 sf

Rooftop Deck – 1,000 SF

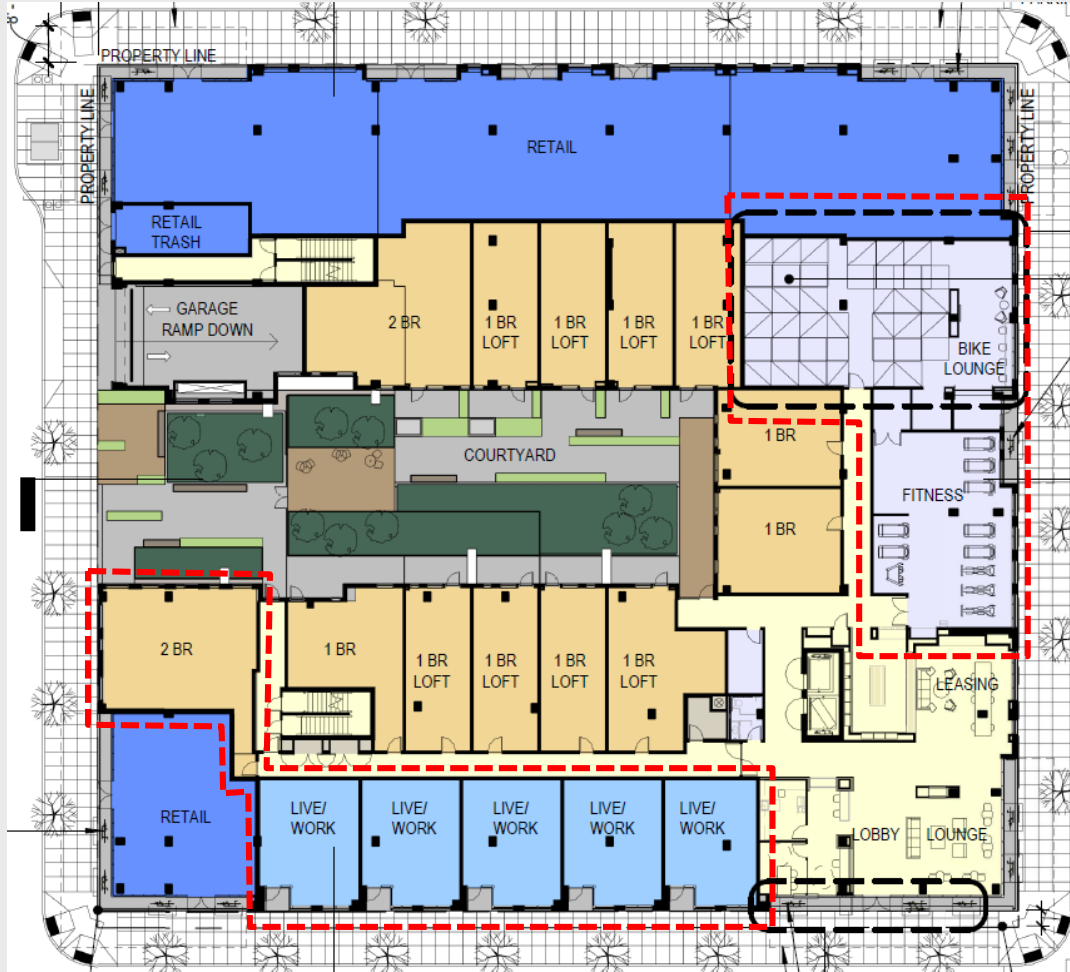
Active Ground Floor – DAR concern

- Retail & office need, focus along Morrison, Belmont & 7th
- Residential amenities shift to quieter 6th
- “Drawn blinds” when residential units occur at ground floor.

Replace ground floor residential unit with active use

Replace live-work with retail/office or design to accommodate residential component at rear (loft) for active/retail at street-edge.

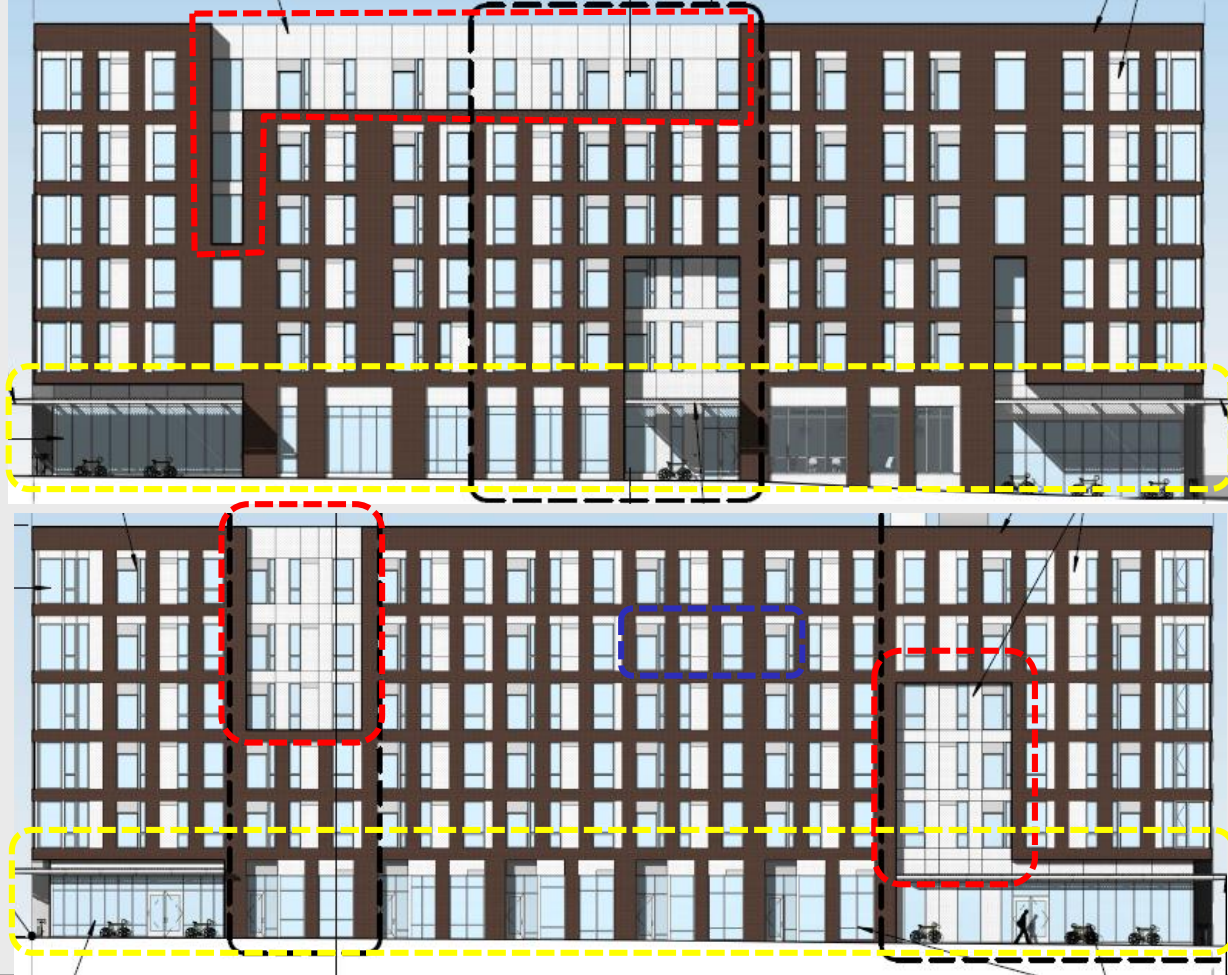
Composition

- Varied building's *base* – *unify, larger storefront patterning*
- Carved out masses – *more logical*
- Scale & monotony of courtyard elevations – *extend more brick into courtyard, group windows*
- Louvers – *more integrated & details needed*
- Canopies – *lighter design/material given 8' depth, add to courtyard residential entries*
- Balconies & façade treatments respond to the different frontages

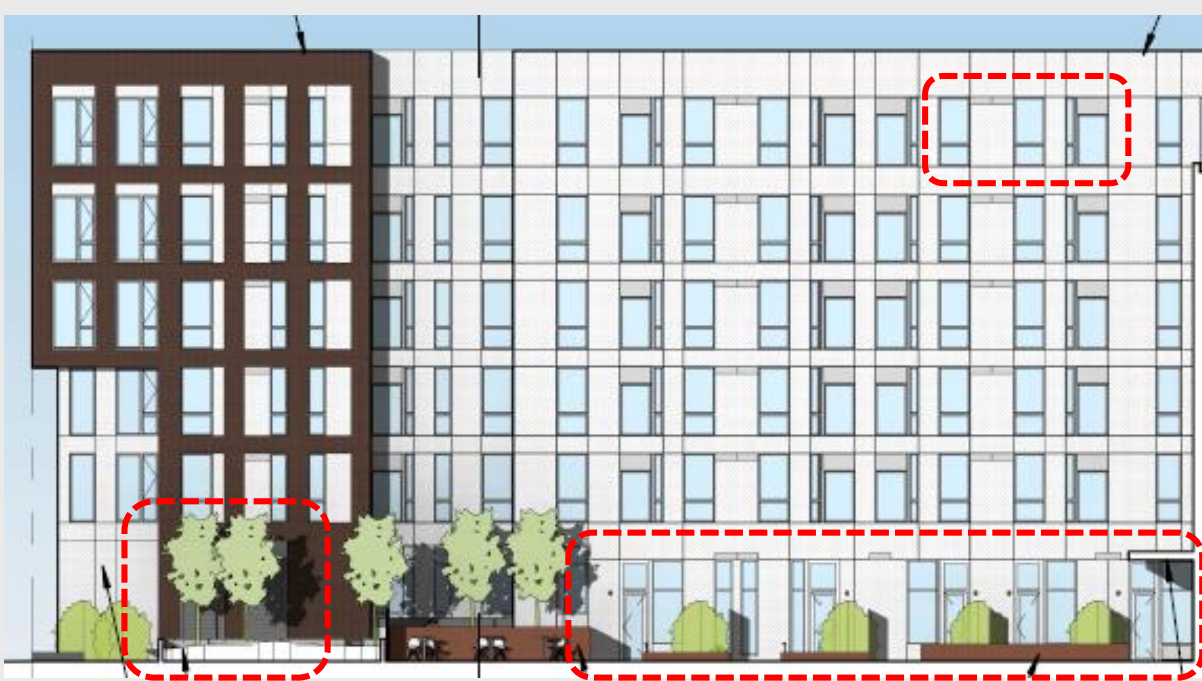
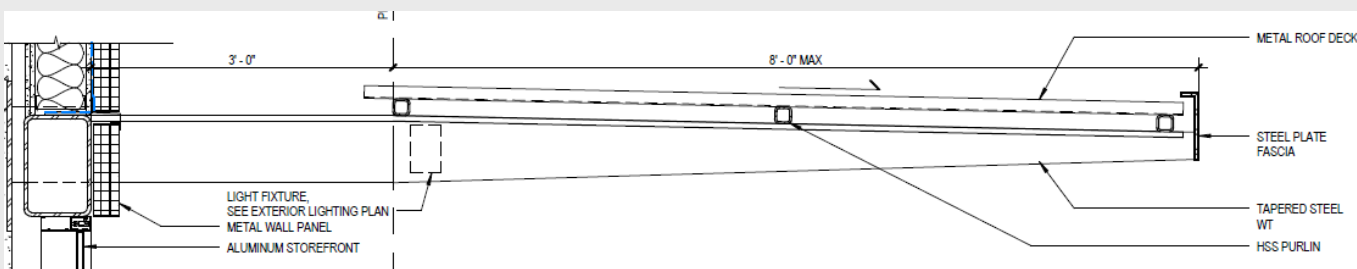
Composition

- Varied building's base – unify, larger storefront patterning at live-work
- Carved out masses – more logical
- Scale & monotony of courtyard elevations – extend more brick into courtyard, group windows
- Louvers – more integrated & details needed
- Canopies – lighter design/material given 8' depth, add to courtyard residential entries
- Balconies & façade treatments respond to the different frontages

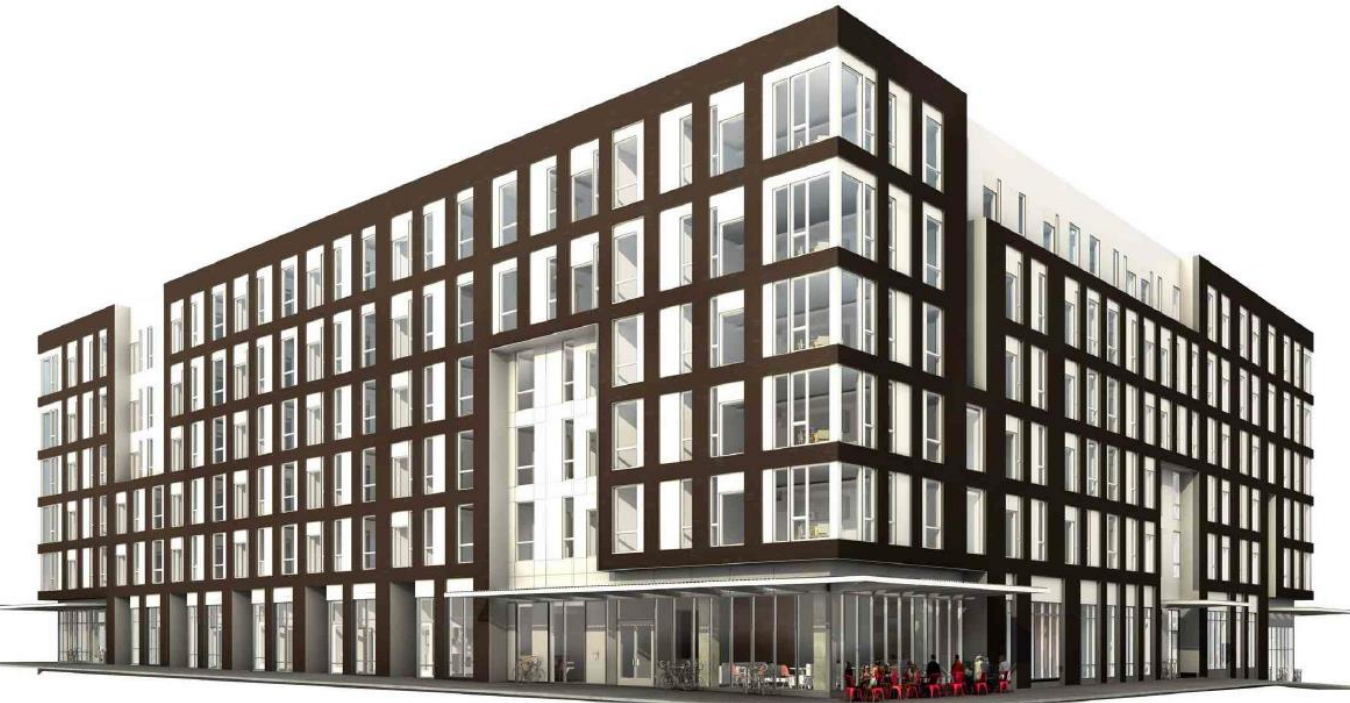
Compatibility – early 20th century buildings in area:

- Carved out masses – more logical, express 1/4 or 1/8 block development patterns, brick wrap returns (less applied)
- Use of white, flat metal panel – other profile or color?
- Shallow window depths (3'') – 7'' more typical

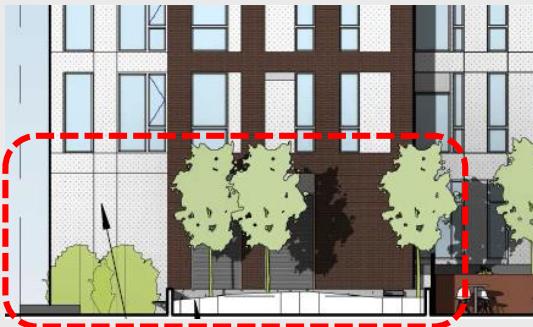
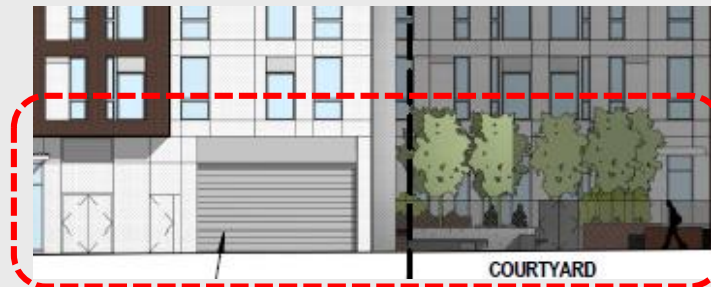
Amount of usable space – DAR concern

- 42' width is tight w/amt of stormwater planters
- Widen, reduce/remove non-stormwater planters, etc

Garage Entry Adjacency

- Improve design of west and south wall of garage
- Bigger move – re-orient courtyard away from garage entry

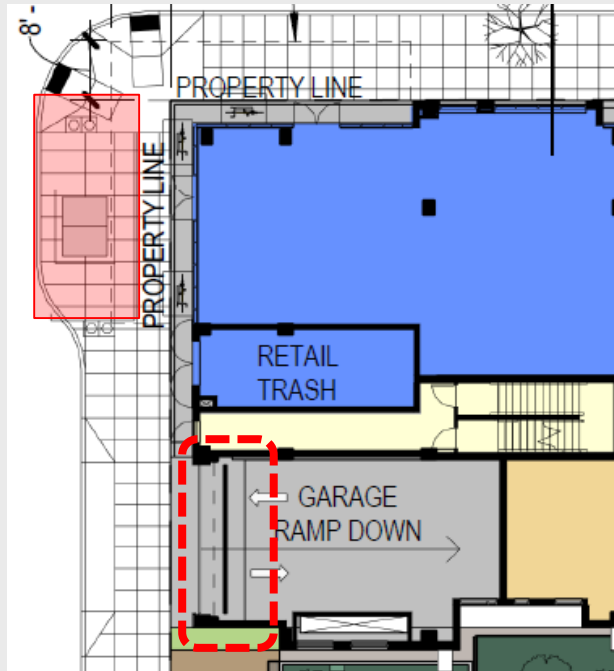
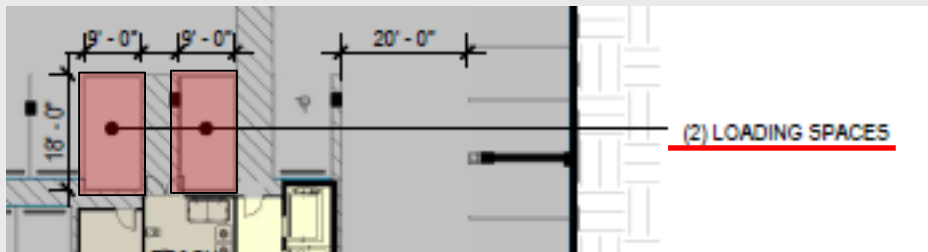
Garage door Location – 3’ setback from bldg face acceptable to PBOT

- *Driveway Exception approved May 1st*

Loading Modification – PBOT supports vertical clearance reduction from 10’ to 9’ for 2 small basement level loading spaces.

Transformer Location – underground in curb extension at NE or SW corner acceptable to PBOT

- *Applicant needs to initiate Driveway Exception to ensure location will work for utility provider & curb extension design*
