**Liquid Storage Tanks at the Critical
Energy Infrastructure (CEI) Hub
Seismic Assessment of Tank Inventory**

May 2019

REPORT SUMMARY

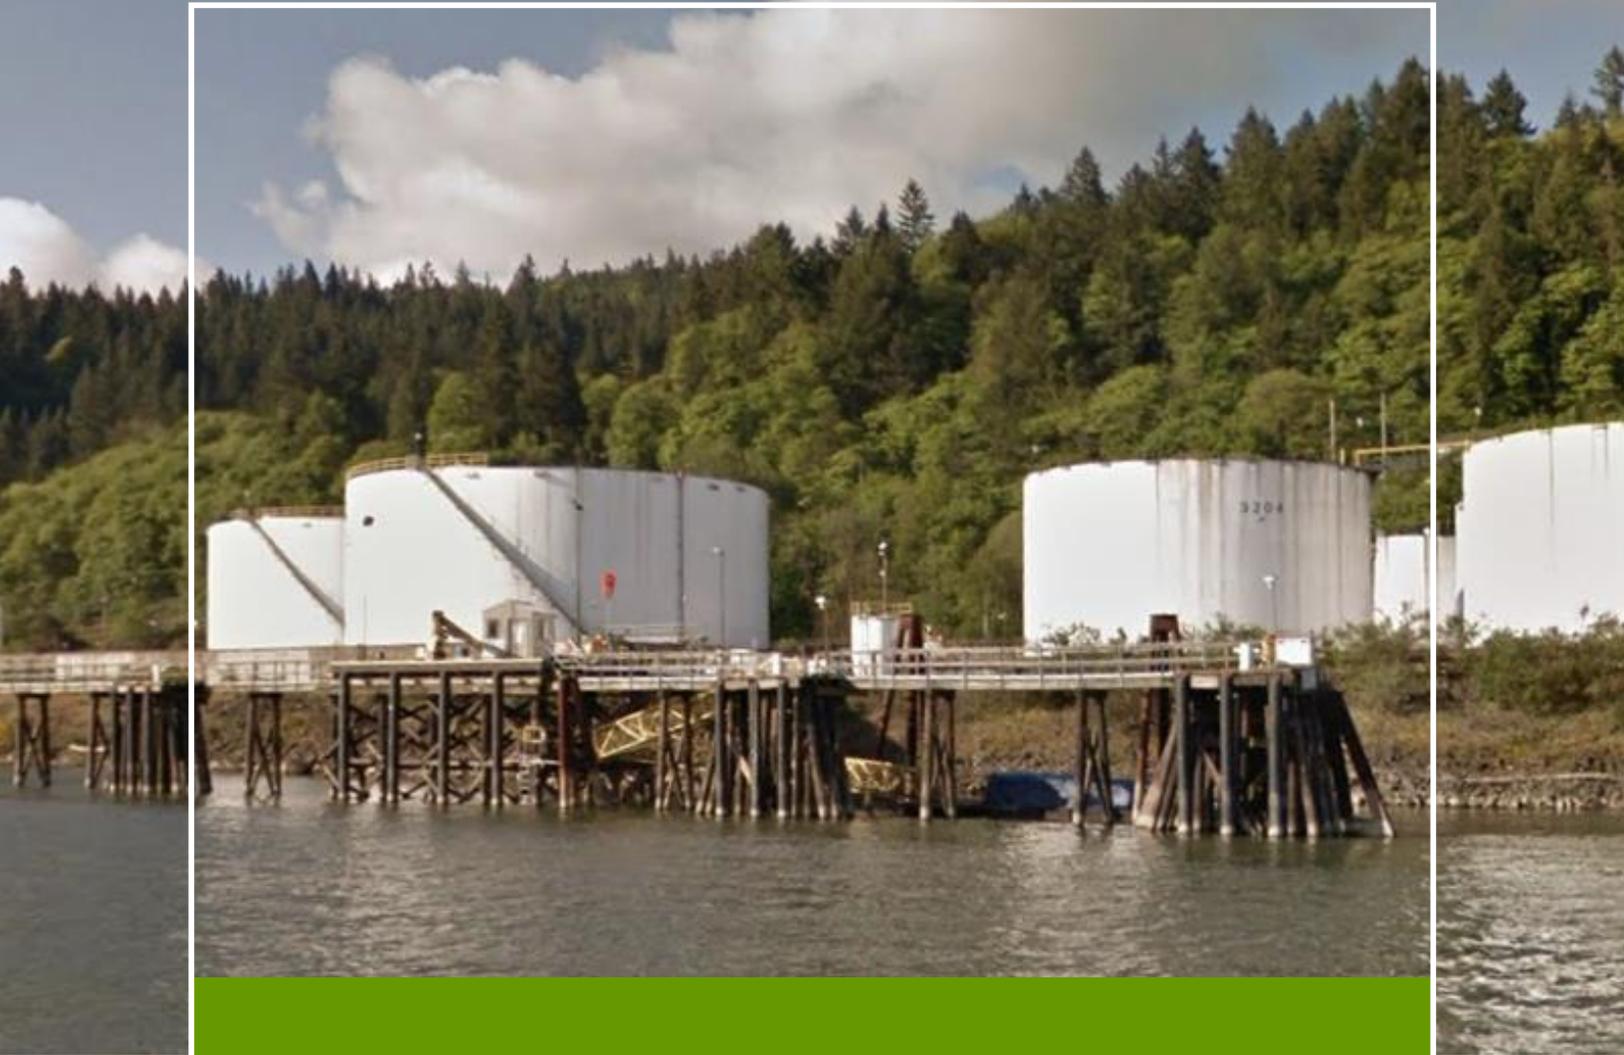
Photograph of liquid fuel storage tanks for NuStar Energy L.P. that form part of the Critical Energy Infrastructure Hub in Portland, OR.

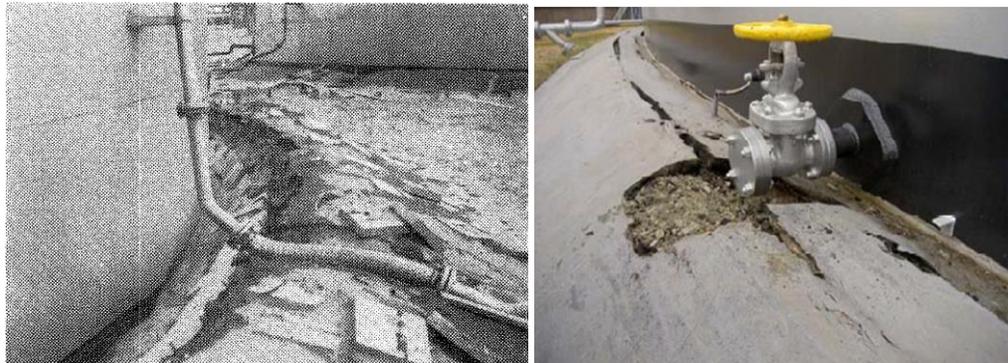
Figure 4: Liquefaction Induced Settlement following 1964 Niigata and 2011 Tohoku Earthquakes in Japan (Watanabe 1966, Zama et al 2012)

The Great Alaskan earthquake of 1964 resulted in numerous examples of damage caused by liquefaction. Another 1964 earthquake occurred in Japan and was a magnitude 7.6 near the city of Niigata. Two oil refineries were located near a river and had liquid fuel storage tanks built on loose sandy ground. Settlements due to liquefaction were observed to be 8 to 12 inches on compacted ground and up to 20 inches of unequal settlement in uncompacted sand. These resulted in many damaged tanks in both refineries. In contrast, newly built tanks constructed

on compacted soil at the refineries settled uniformly, and approximately 1 in. These tanks exhibited minimal to no damage and remained operational, while surrounding tanks were severely damaged from large ground settlement (Watanabe 1966).

Liquefaction induced lateral spreading can move entire tanks or cause relative ground deformations of the tank. During the 2011 Tohoku subduction zone earthquake, surrounding soil spread and caused uplift on the side of a tank of approximately 20 inches, resulting in the tank cracking and the contents leaking out (Zama et al 2012). An example of tank settlement and of lateral spreading induced uplift is photographed in Figure 4. In addition to damaging the tank itself, liquefaction can sever I/O connectivity. These examples underscore that minimizing the effects of liquefaction can minimize the risk of damage to liquid fuel storage facilities.

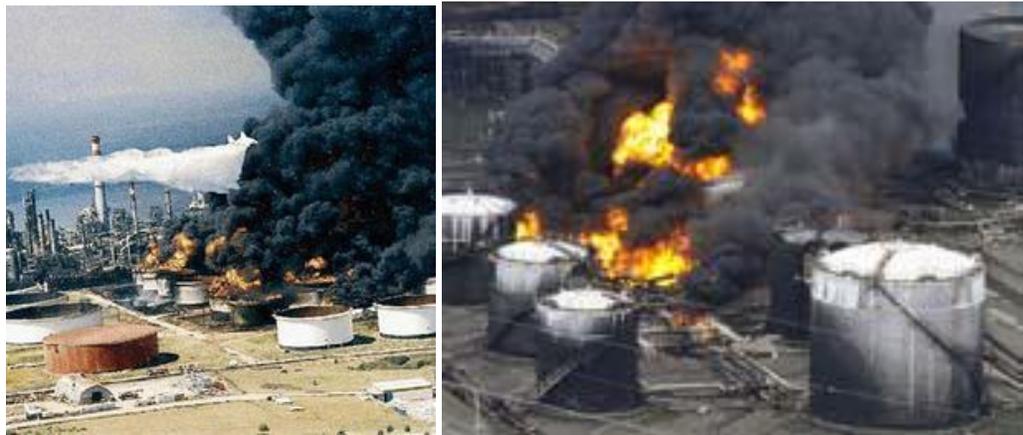
Figure 5: Fire Caused by Tank Damage following 1999 Turkey (left) and 2011 Tohoku Earthquakes (right) (French Ministry of Ecology, Sustainable Development and Energy, 2013)

While fire can be thought of as a secondary effect resulting from the damage caused by the earthquake, it is particularly relevant given the volatile contents of the tanks. Numerous instances of fires at liquid fuel storage facilities following an earthquake have been reported, with examples provided in Figure 5. Approximately 37 miles from the epicenter of the Great Alaskan earthquake, oil storage tanks were constructed in the port city of Whittier on fill that consisted of delta deposits and glacial outwash. All of the storage tanks were completely destroyed by a fire that broke out and burned for three days. The fire, and subsequent tsunami, destroyed the evidence and the cause of the fire was never determined. Two possible causes included a live power line that was snapped during the earthquake, or fuel from a leaking tank could have spilled into an operating boiler (Kachadoorian, 1965).
