APPEAL SUMMARY

Appeal ID: 24525	Project Address: 900 SW Washington St
Hearing Date: 1/20/21	Appellant Name: Steven Rupert
Case No.: B-004	Appellant Phone: 5033176573
Appeal Type: Building	Plans Examiner/Inspector: Katherine Aulwes
Project Type: commercial	Stories: 35 Occupancy: S, A, B, M, R Construction Type: I-A
Building/Business Name: Block 216	Fire Sprinklers: Yes - Throughout
Appeal Involves: Erection of a new structure, Reconsideration of appeal	LUR or Permit Application No.: 19-130673-CO
Plan Submitted Option: pdf [File 1] [File 2]	Proposed use: Mixed Use Retail, Hotel, Office, Condominium Building

Appeal item 1

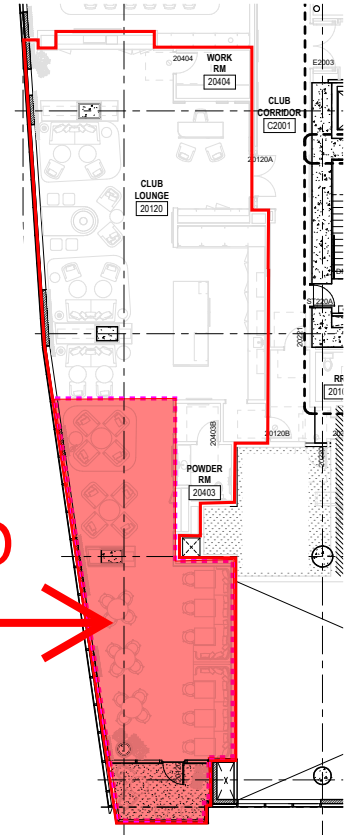
**CLUB LOUNGE
MAXIMUM OCCUPANT LOAD
107 OCCUPANTS**

**LIMITED AREA NOT TO EXCEED
49 OCCUPANTS**

SIGN AT NORTH WALL OF LIMITED OCCUPANCY AREA:

**MAXIMUM OCCUPANCY
BEYOND THIS POINT
49 OCCUPANTS**

The width at the north end of the seating and reading room area in question does not exceed 13rd of the overall diagonal. However, we believe the occupant load of this area should not require two exits and therefore a narrower dimension should be found acceptable. Due to the intended use of the club lounge amenity as required by the hotel operator's program, the occupancy of this area will be much lower than the result of the common 1/15sf calculation for A-3 occupancies. The capacity of the seating arrangement as shown for this area is also reflective of this lower occupant load anticipation. If a restriction of 49 occupants is applied to this area, only one exit is required. By posting signage indicating this limitation all staff of the hotel operator who control access to this lounge and manage the use of this area will be well informed of this limitation. Having the occupant load limit posted directly north of the space in addition to a graphic indication on the primary occupant load sign for the Club Lounge will reinforce an understanding of this limitation.
