### **Greenbrier Gunderson**

Existing Building Repair - Building Code Appeal  
WJE No. 2021.1080.1

Greenbrier  
Gunderson Ways 2  
Building Repair  
4350 NW Front Avenue  
Portland, OR 97210

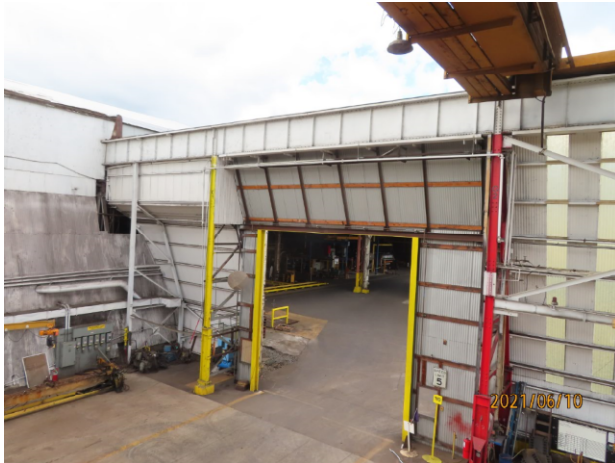
Figure 5. Large wall opening at the southwest corner of the building.

The Ways 2 building is classified as a Risk Category II building. This Risk Category includes seismic performance objectives for some multi-story apartment buildings and low-rise office buildings with permanent occupants, complex floor plans with multitudes of obstacles obstructing egress like partitions, miscellaneous clutter, stairs, and doorways. We are not suggesting the Ways 2 building be considered a Risk Category I building, but clearly this building represents a very low hazard compared to other buildings in a very generalized category. The open floor plan of the building is uniquely suited to allow unobstructed egress from the building during or after a seismic event through four large unobstructed permanent wall openings (Figure 5). Provided that the large wall openings are not closed with rigid doors but rather with roll up flexible covers, the openings are more likely to remain open if deformed or racked, compared to rigid doorways in other Risk Category II buildings. As shown on a floor plan of the building on Sheet G004, attached to this submittal, maximum exit access travel distance is less than half of that required in the OSSC.
