RESTROOM FLOOR REPAIR
OAKS PARK ROLLER RINK
7805 SE OAKS PARK WAY
PORTLAND, OREGON

SHEET CONTENT
PARTIAL PLANS

SHEET
S2.01

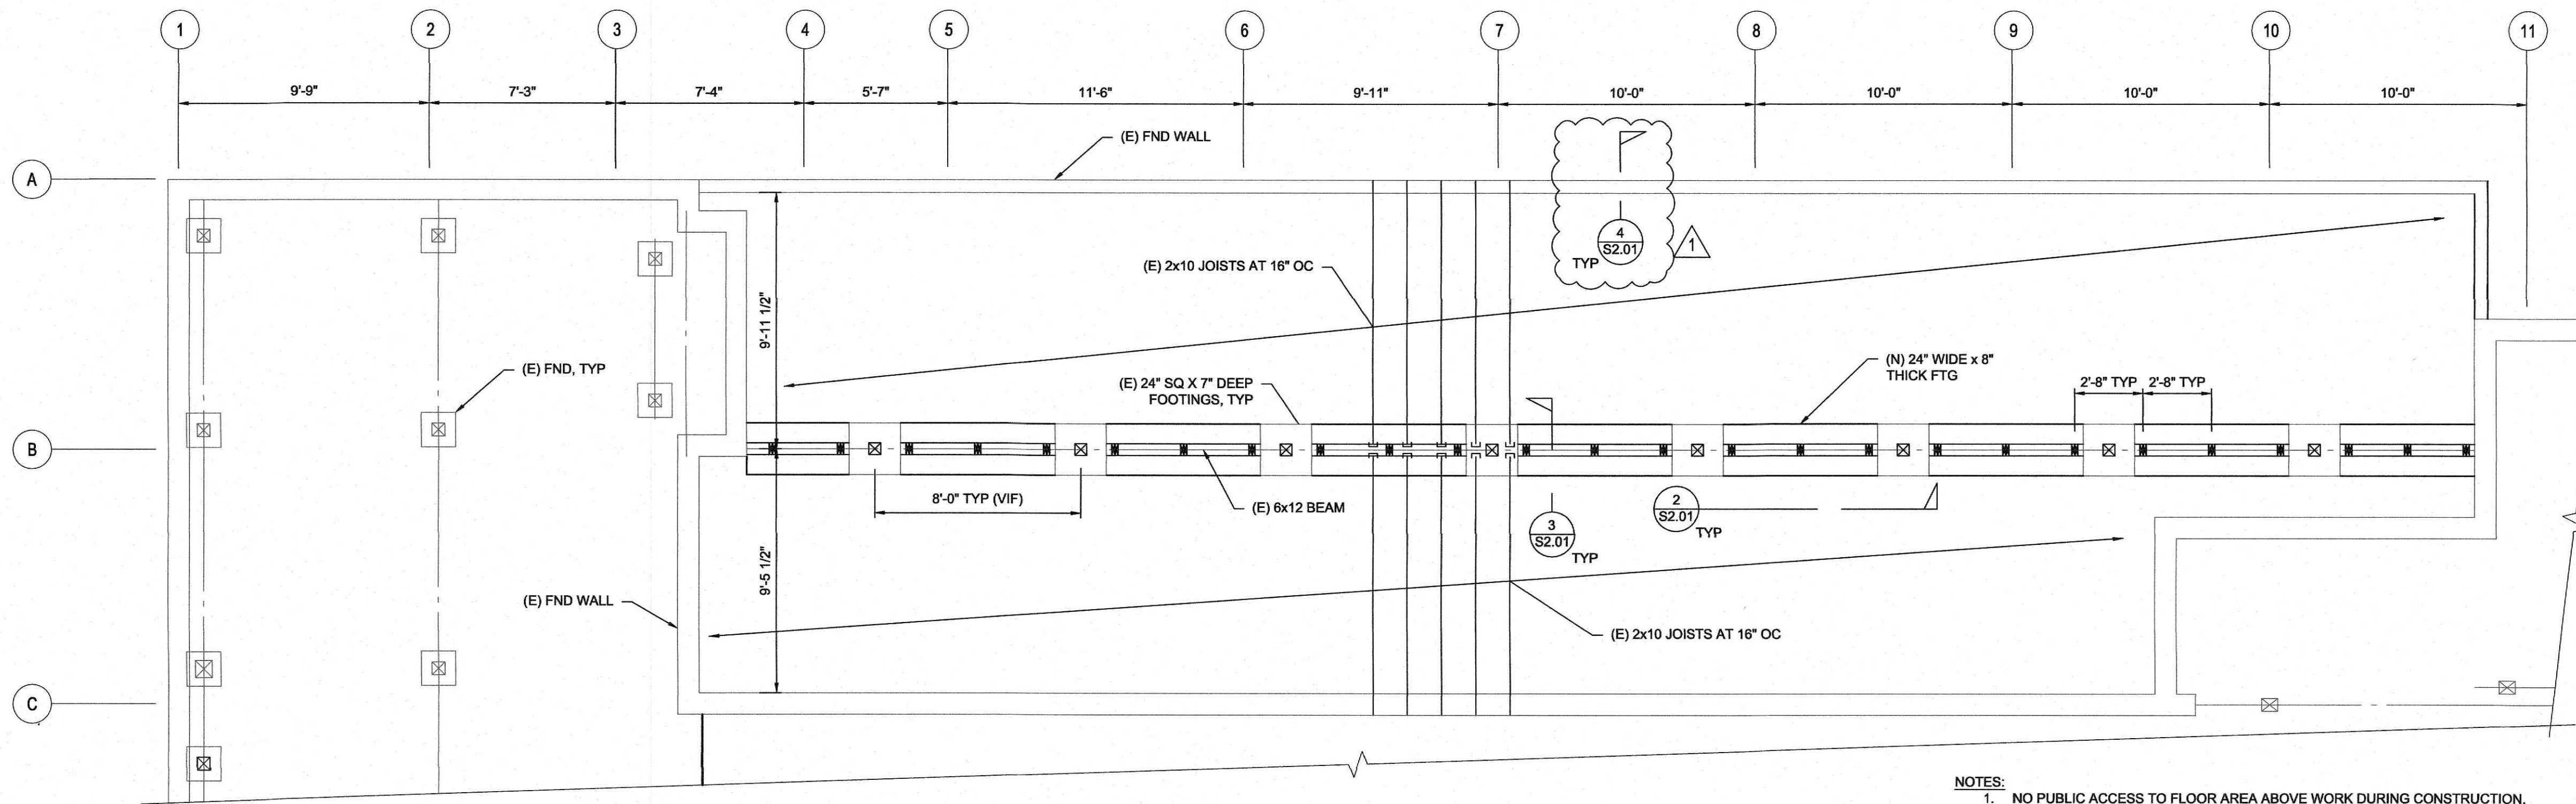
1 PARTIAL FOUNDATION AND FRAMING PLAN
1/4" = 1' - 0"

NOTES:
1. NO PUBLIC ACCESS TO FLOOR AREA ABOVE WORK DURING CONSTRUCTION.

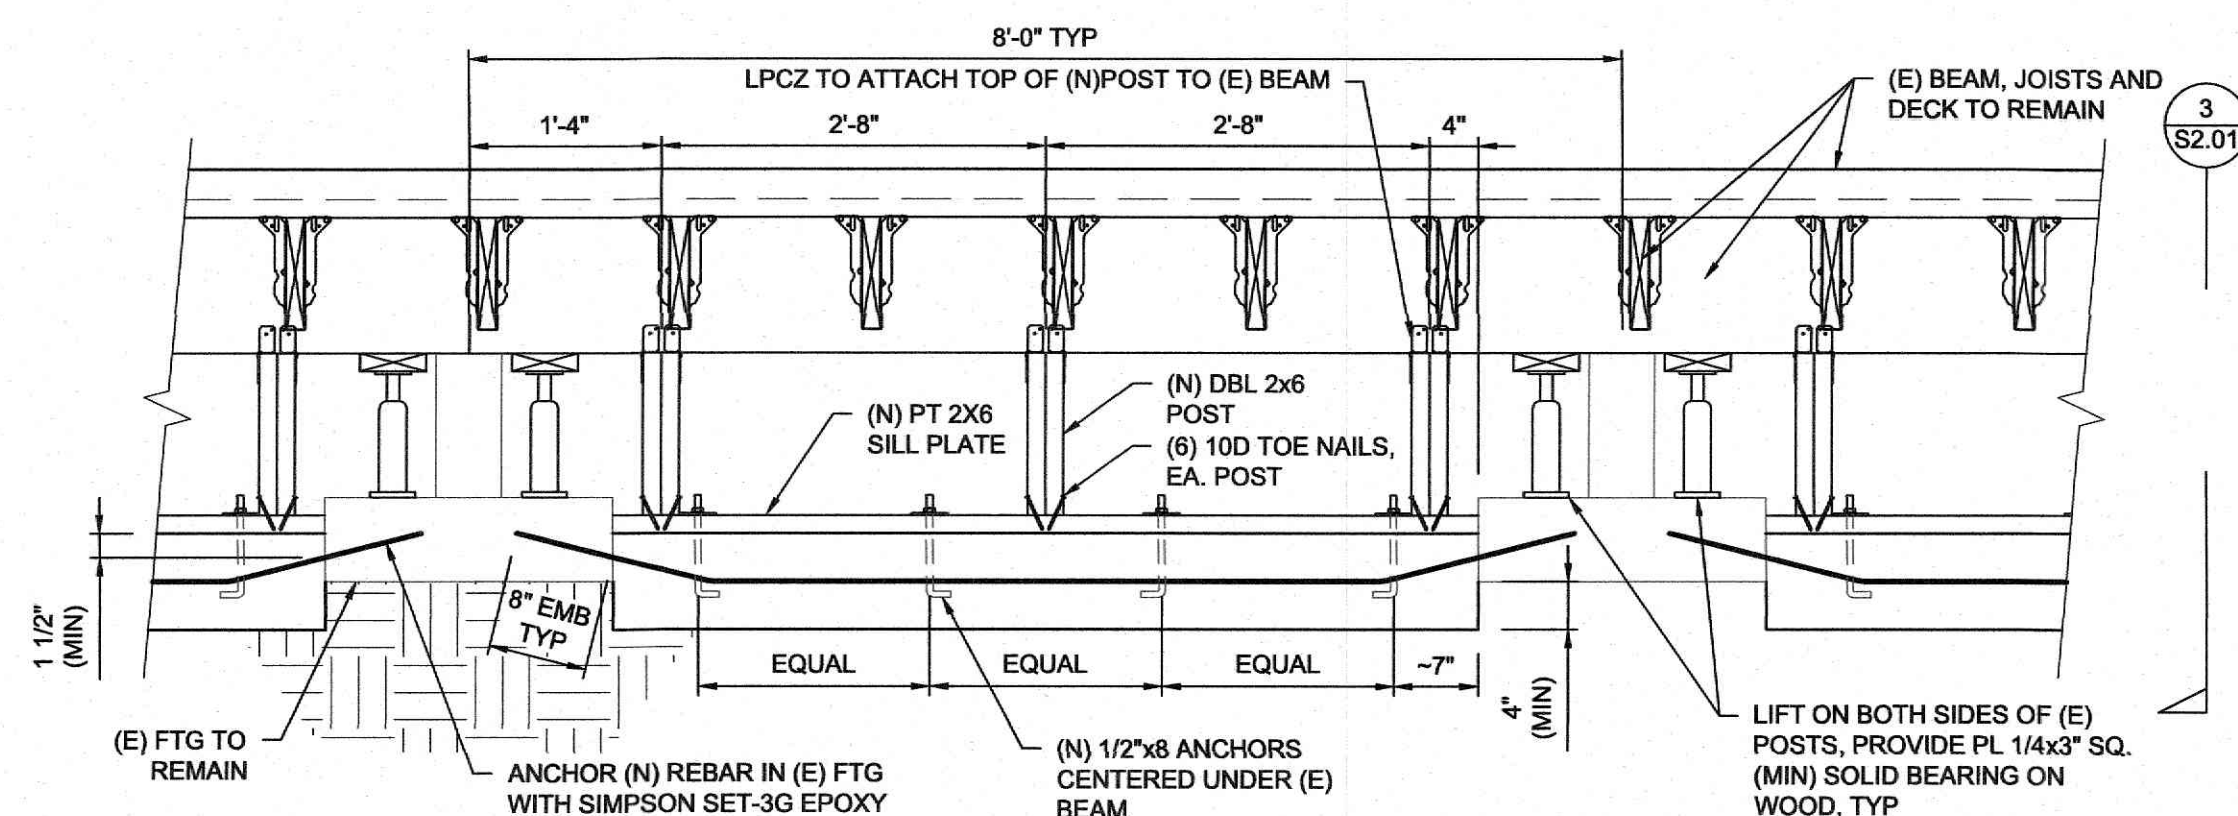
2 BEAM SUPPORT SECTION
3/4" = 1' - 0"

NOTES:
1. USE EXISTING FOOTINGS TO LIFT FLOOR TO LEVEL PRIOR TO INSTALLING NEW FOOTINGS. LIFT ENTIRE FLOOR AT THE SAME TIME, DO NOT LIFT IN SECTIONS.
2. NEW FOOTING MUST EXTEND A MINIMUM OF 4" BELOW EXISTING GRADE AND SOIL BELOW FOOTING TO BE HAND TAMPED PRIOR TO CONCRETE PLACEMENT. GEOTECHNICAL ENGINEER TO REVIEW SOIL CONDITIONS PRIOR TO CONCRETE PLACEMENT TO DETERMINE IF ADDITIONAL SOIL CONDITION IS REQUIRED.
3. NOTIFY EOR IF SPANS BETWEEN EXISTING POSTS EXCEED THE DIMENSIONS SHOWN BY MORE THAN 6".

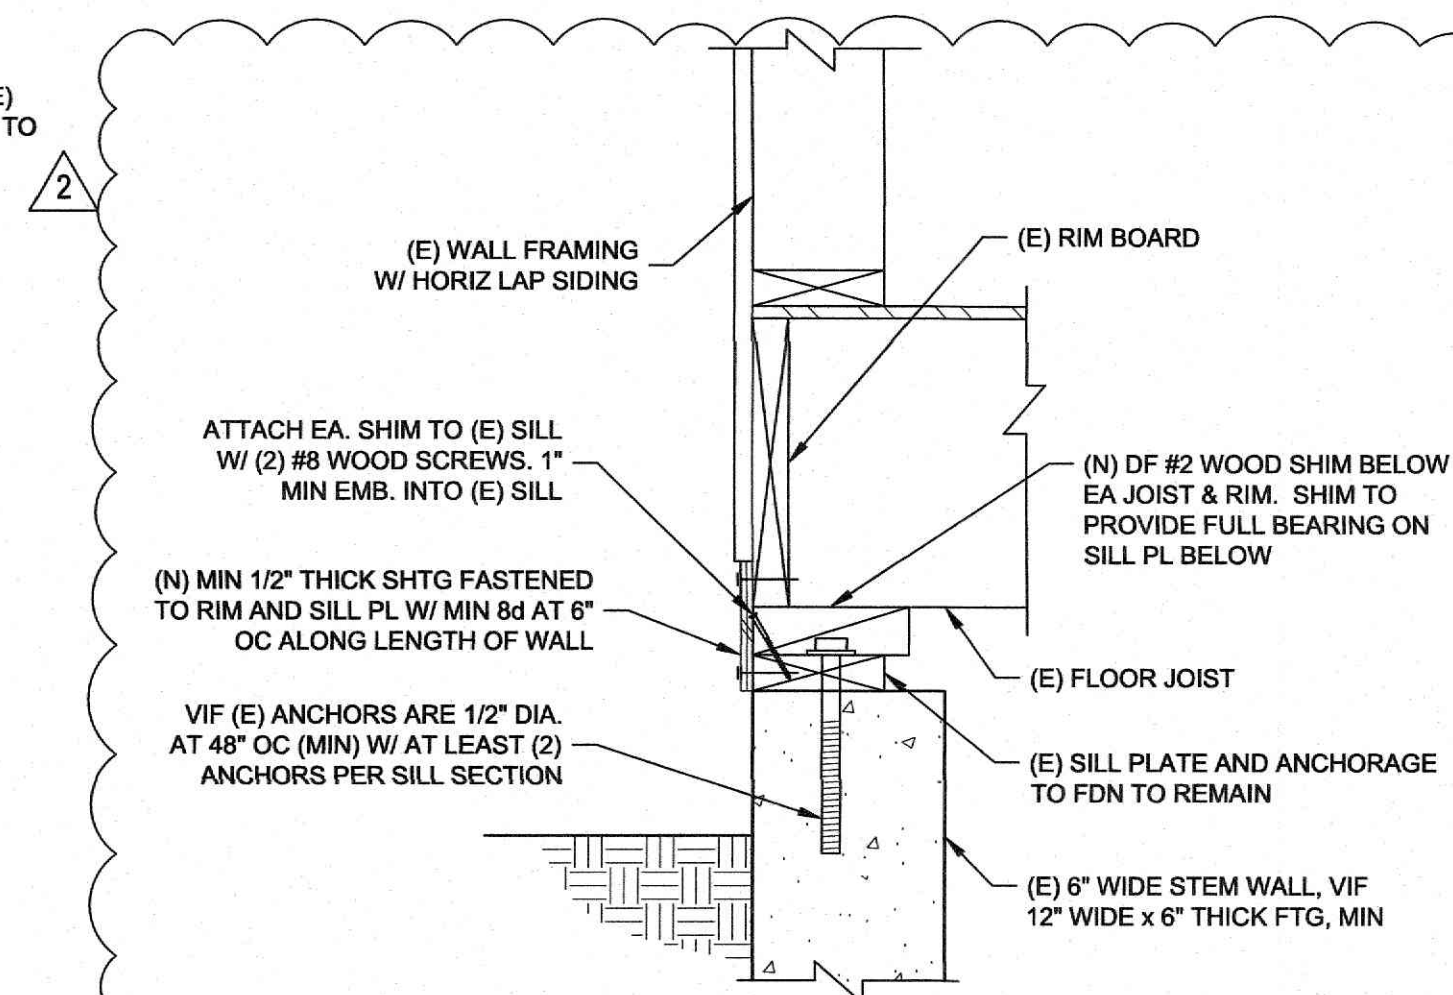
4 WALL TO FOUNDATION CONN
1 1/2" = 1' - 0"

NOTES:
1. LIFT FLOOR TO LEVEL PRIOR TO INSTALLING NEW SHIMS BELOW JOIST. LIFT ENTIRE FLOOR AT THE SAME TIME, DO NOT LIFT IN SECTIONS.
2. ALL SIDING, FLASHING AND WATERPROOFING DESIGNED BY OTHERS.
