Historic Landmarks Commission Briefing

BRIEFING MEMO

Date: April 1, 2024
To: Historic Landmarks Commission
From: Staci Monroe Design Review
503.865.6516 | staci.monroe@portlandoregon.gov
Re: David Campbell Memorial Restoration
Landmarks Commission Briefing on April 8, 2024

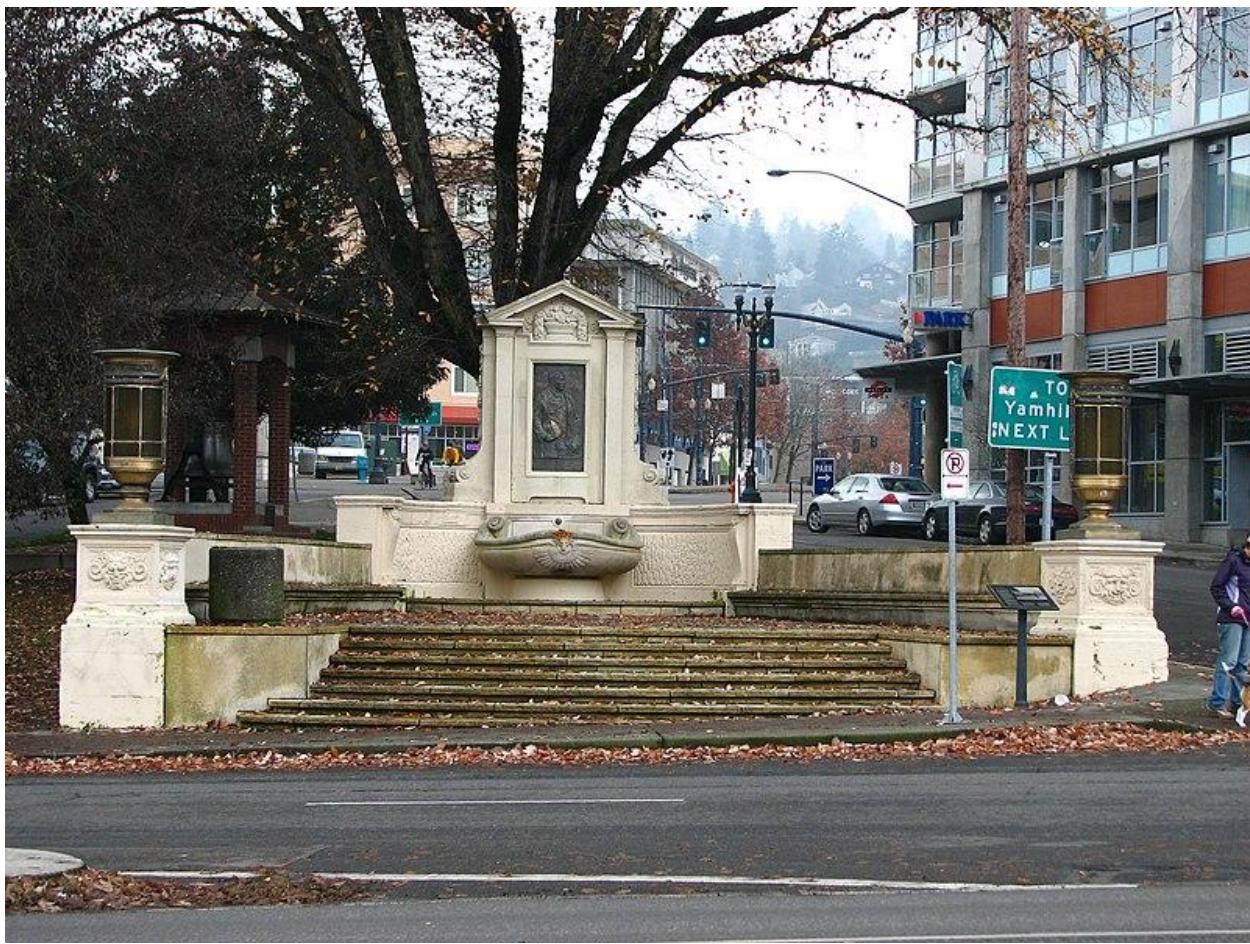
Here is a view of the DCM in current times.

Recent years have been hard on the DCM and vandalism has taken its toll. It is time to make repairs as we make efforts to also build the PFMP. We are proposing four changes to the existing DCM.

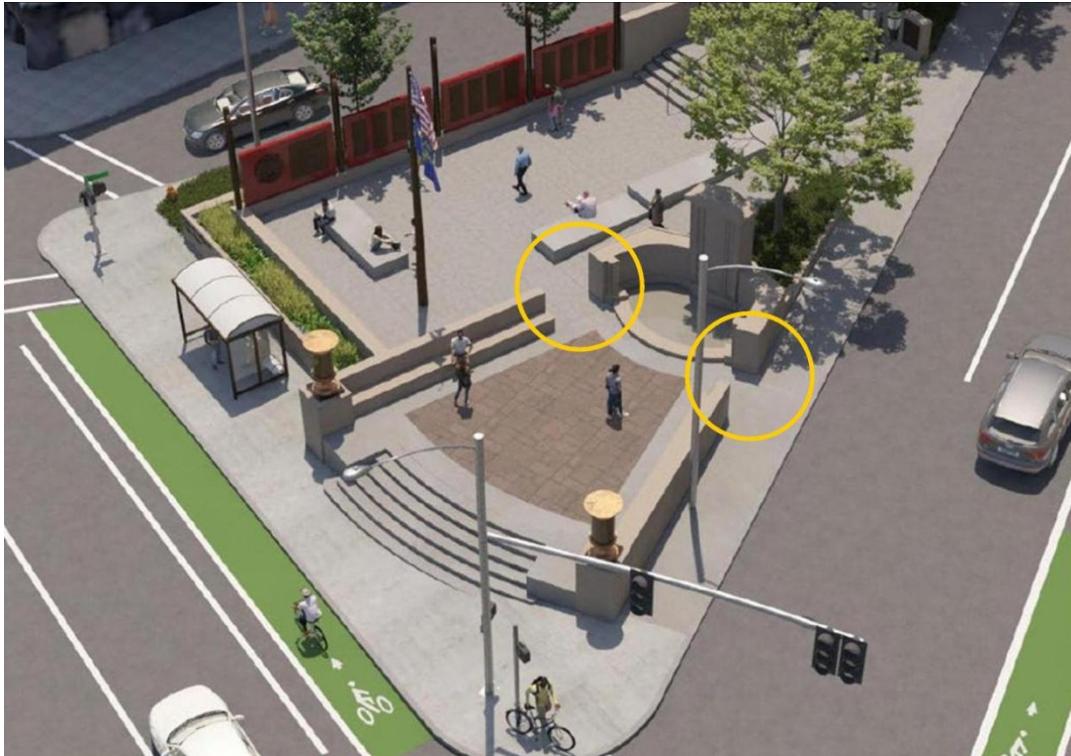
2. **Water Drainage** - Over the past 96 years, the south end of the floor, in front of the fountain, has settled a few inches, causing water to stand on the floor through much of the winter. Other drainage solutions might be found, but would likely be expensive and very intrusive on the DCM. Opening the walls allows water to flow out onto the sidewalk and into the storm collection system.

This was presented at the early assistance meeting with the city of Portland and reviewed by Hilary Adam. She indicated favor for this. The image shows the places where the walls would be opened.

1. **Pedestrian Movement** - In order to connect the DCM to the memorial plaza, we need to open a path through the walls. To do otherwise would require our project to extend past existing sidewalks or curb lines, which makes the entire project cost prohibitive. PBOT has put extensive time and effort into the current pedestrian and traffic paths and favors a project that does not require modifications nor extend beyond the curb line of the triangle.

3. **Repair Material** - The material taken from the wall openings would be saved and used for places in the DCM that need repair. It would be very difficult to match the existing stone if pieces salvaged from this modification were not available. This allows originality to be maintained in the DCM.

4. **ADA Access** - Very importantly, opening the walls allows for ADA access to the DCM, something that has not existed for the past 96 years. It also allows a direct connection to the PFMP, thus activating both sites as a single operating unit.

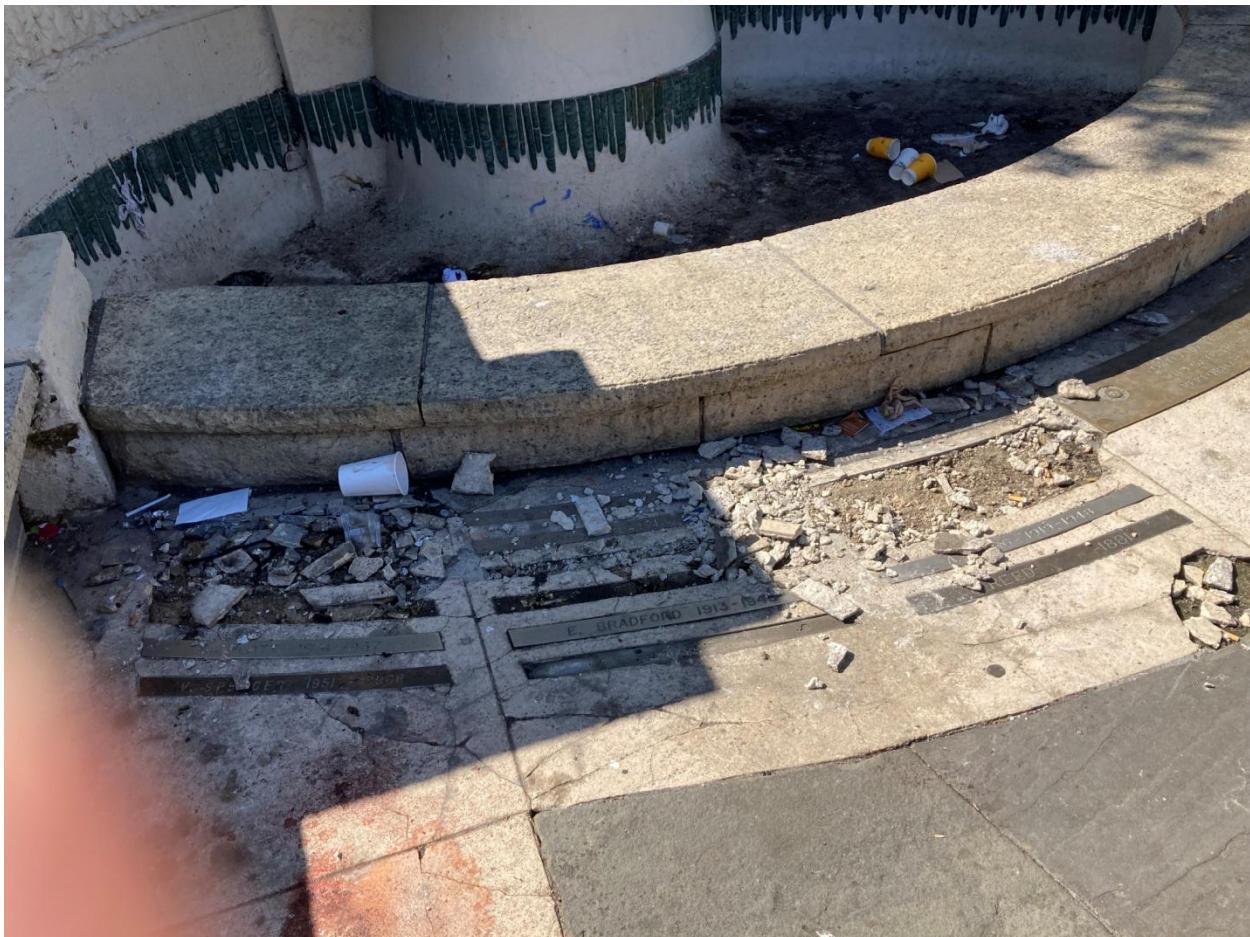
In September 2023, severe vandalism occurred with the theft of 14 bronze name plates (of the 36 in place), each representing a fallen firefighter. Extensive damage was done to the floor in front of the fountain. This cannot be easily repaired. While the name plates could be re-produced, they would lose the character that matches the time periods in which they were created and installed. Besides that, the 36 name plates that existed there failed to represent the other 40 firefighters who have died in service. The new memorial plaza will carry all the names of fallen firefighters, along with proper interpretation, leaving the DCM to be representative of Fire Chief David Campbell, as it was intended when built.

Below is a photo of the damage done by the vandalism.

Consultation with a stone restoration expert indicates that the bluestone which makes up the majority of the DCM floor is easily acquired and matched to the existing floor. Our request is to repair the floor, matching it to the balance of the DCM floor.

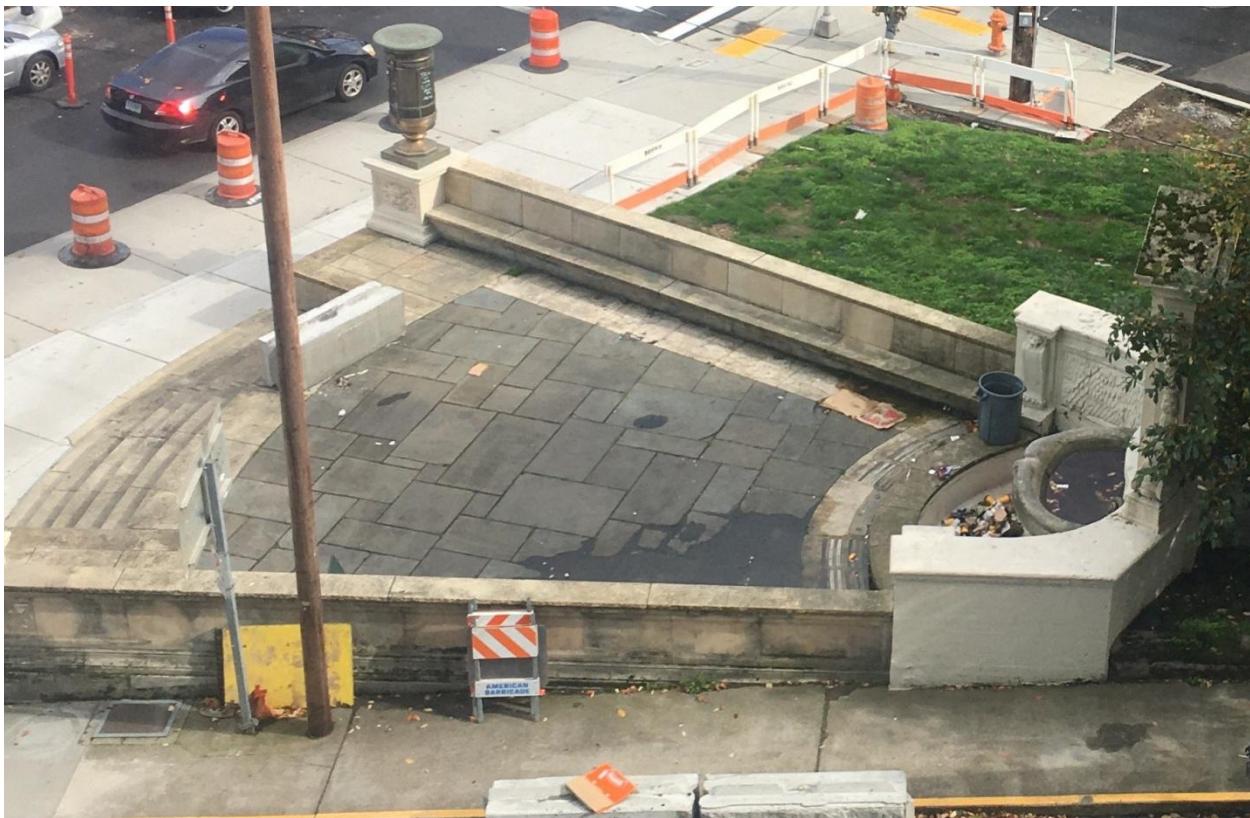
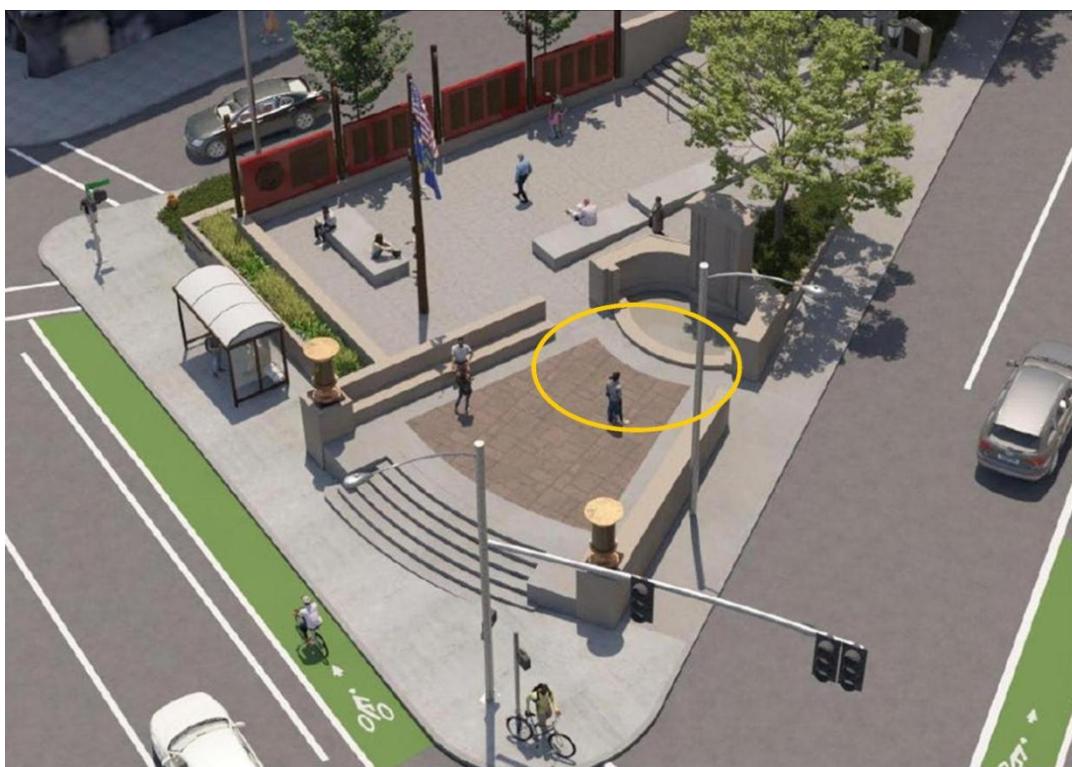
This image shows a view of the floor as it looks today next to the area needing repair, envisioned in the design rendering.

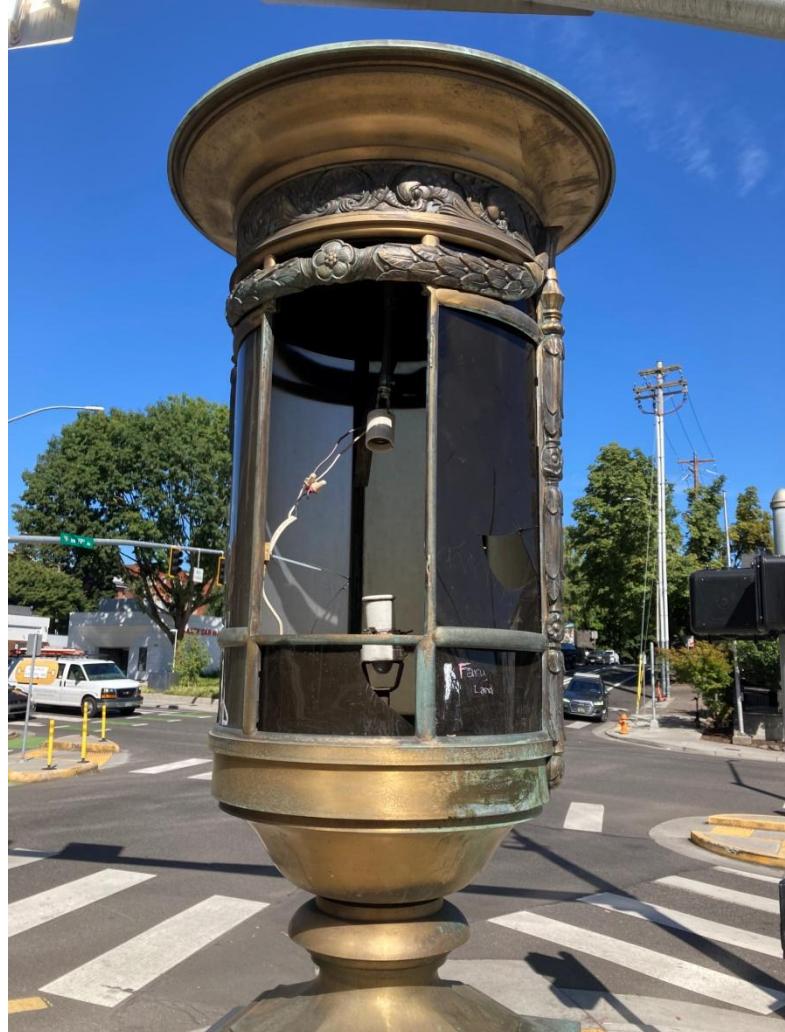
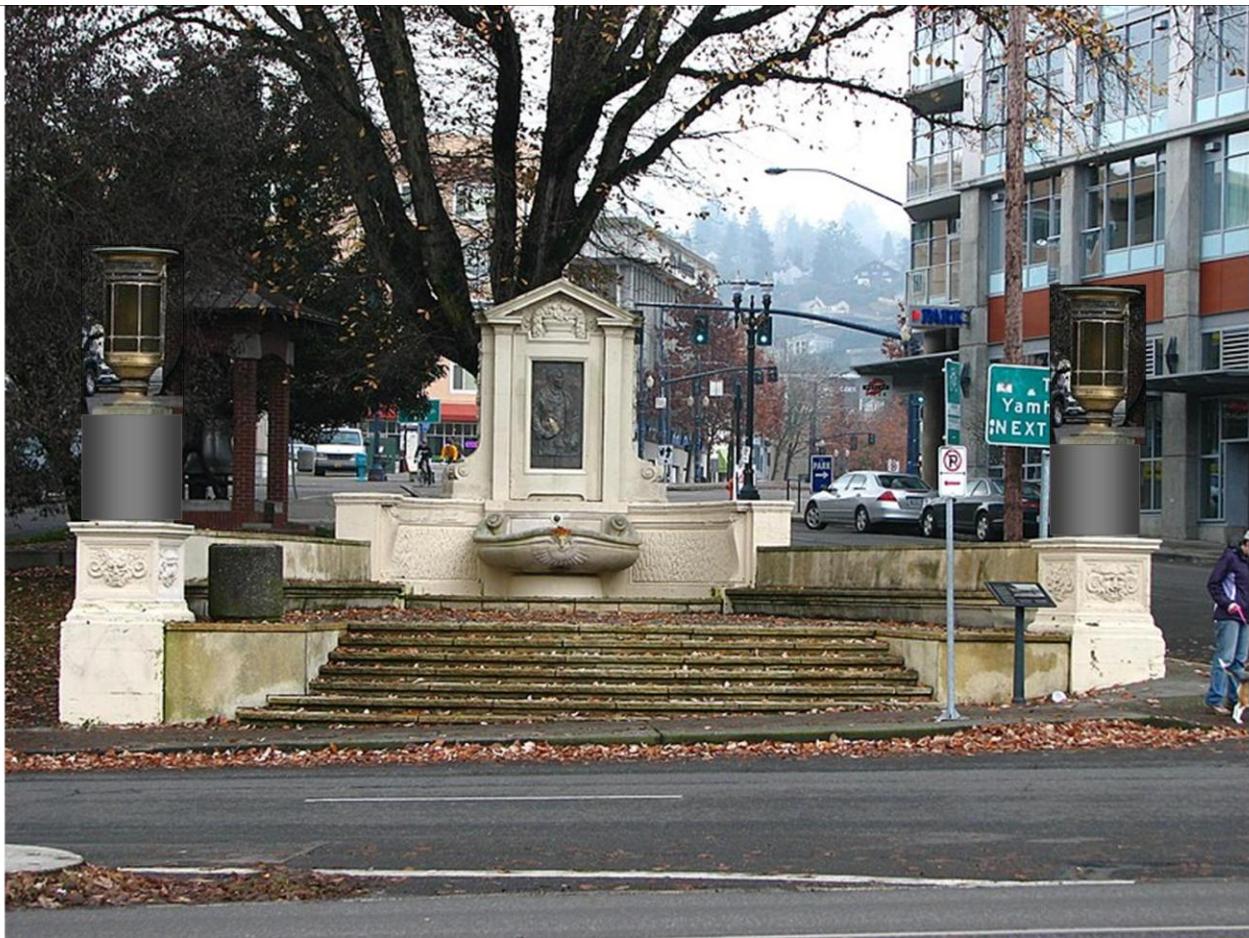
The lanterns have been the subject of vandalism for many years. Sometime long ago, Portland Fire quit putting glass lenses in because they are constantly broken. They are the subject of much graffiti and attempted electrical power theft. After the recent vandalism that found the name plates stolen, the doors to both lanterns had also been torn off of the lanterns and were not found.

The photo shows the typical condition of the lanterns.

Our suggested solution is to elevate their position so they are not so easily reached. Right now, the door opening seen in the photo is approximately six feet above the floor of the DCM. Stepping up on the bench next to it lessens that reach to about four feet.

Our suggested solution is to elevate the lanterns by placing a 36 inch tall extension piece under the base to raise the lanterns to a height that is out of reach for the casual vandal. The current base is 25 inches square and it can be expanded to 39 inches square.

While anything can be damaged with enough determination, we feel that the ease of access contributes greatly to regular and recurring damage. The solution to the lantern placement might look something like the photo below. The pedestals can be designed to match the lanterns exactly and even be embossed with lettering to help identify the site. They would be made from scratch according to specification. (Please pardon the crude imagery, it is the best we can develop at this time). The foundry that is repairing the metal work on the lanterns is capable of casting the bronze pieces necessary to match the lanterns.

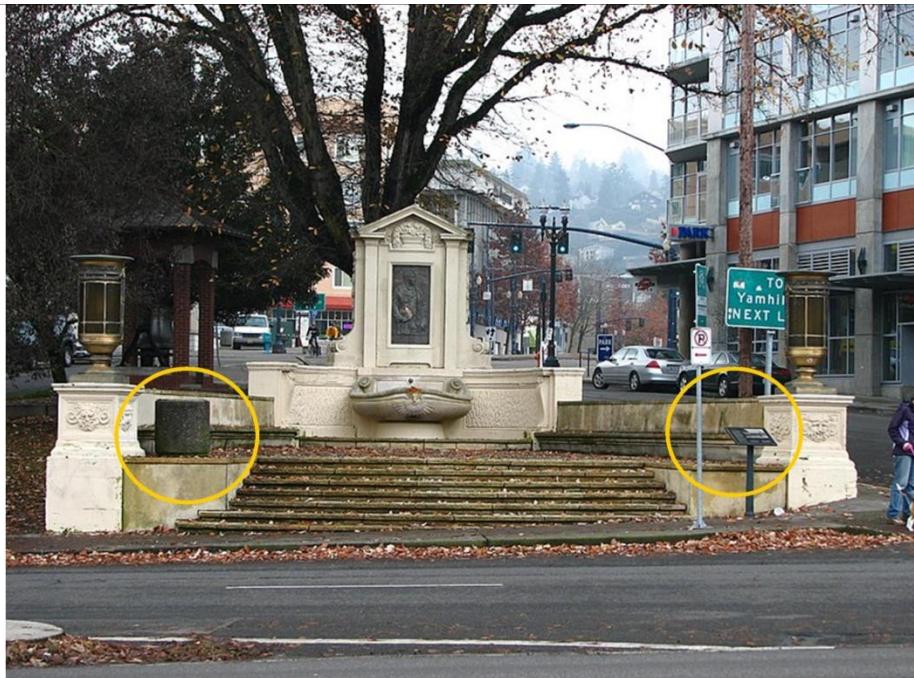
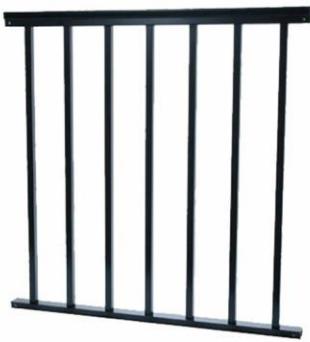
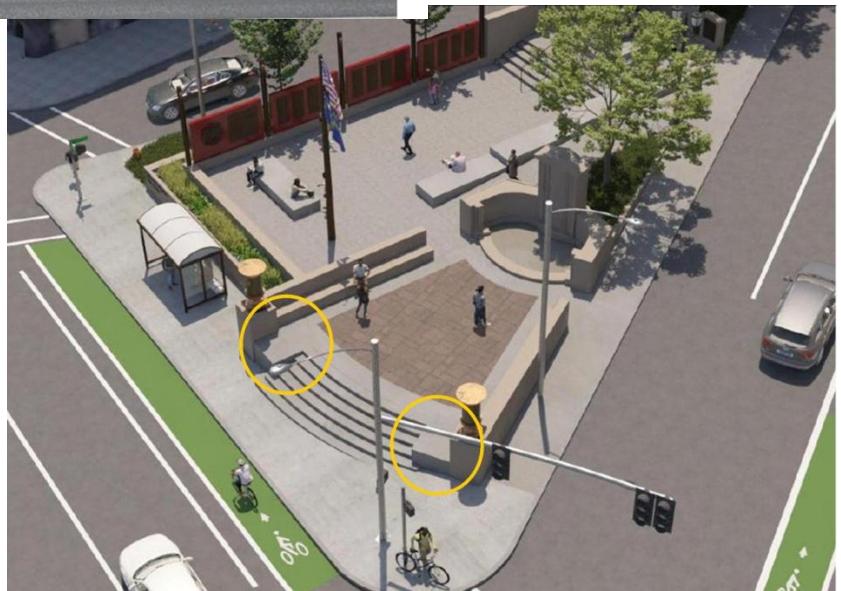
It has long been a concern that the north face, between the lanterns and the stairs, have not protection from a significant drop to the sidewalk below. The drop off on the east and west sides of the DCM floor is 25 inches and 39 inches respectively. It is unlikely that requirements for railings existed in 1928 but today, we know better.

Below is the place on the DCM needing care and an image of a design idea.

We would like to put a railing of sorts at those points. We would look for a design that was simple and unobtrusive to the balance of the DCM. It would span the space between the lantern base and the stair, then return at a 90 degree angle southward to the top step (on both sides). Each wing of the railing would be 57 inches long, with the two pieces at right angles to one another.

We may have the budget to utilize the same foundry repairing the lanterns to create custom fencing that matches other elements. Budget may require a more simple, commercially available solution.
