Subject: **Annual CSO and CMOM Report, FY 2016**
Columbia Boulevard Wastewater Treatment Plant NPDES Permit #101505

Annual CSO and CMOM Report FY 2016

Required by NPDES Permit #101505
for CBWTP and CSO Systems

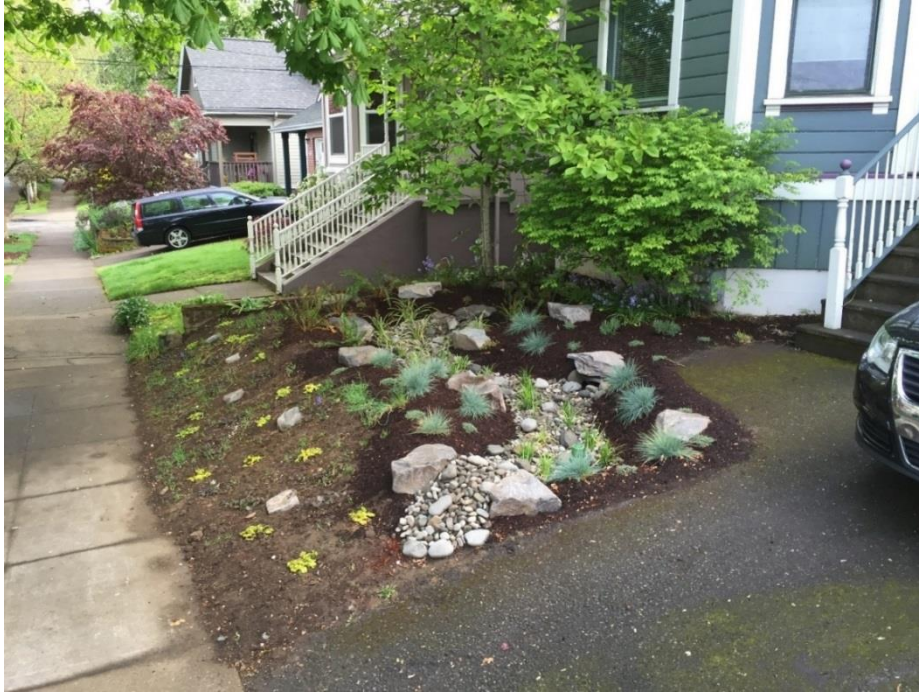
Figure 22 FY 2016 Example Retrofit #1

For FY 2016, 2.1 acres of impervious surfaces were managed by 34 private property stormwater retrofit projects. Two examples of this year's retrofits are shown in
