THE PORTLAND BUILDING RECONSTRUCTION PROJECT

Type III Historic Resource Review

June 26, 2017
LU 17-153413 HR

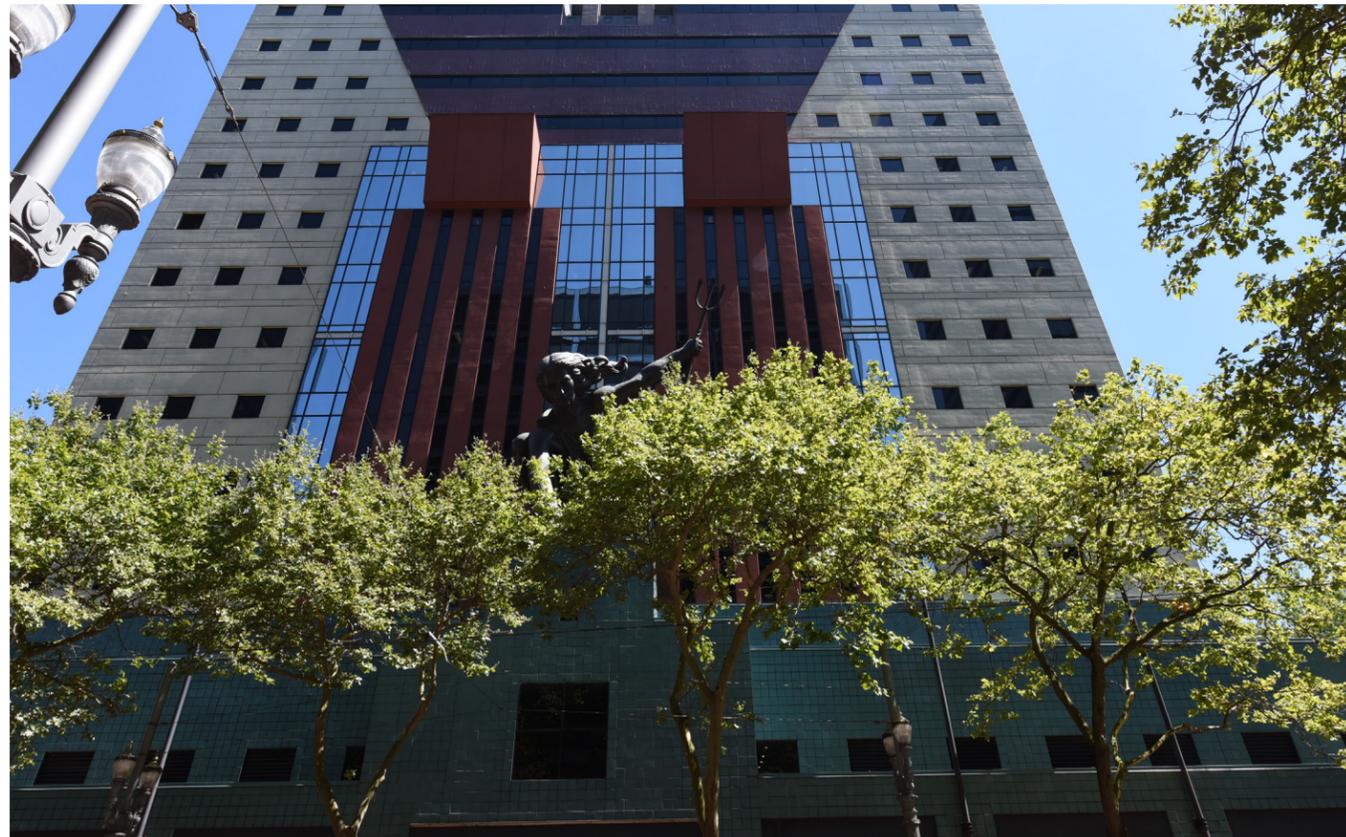
PROPOSED TREE REMOVAL

Significant pruning is currently being performed throughout the canopy of these two middle London Planetrees. These two trees are top pruned to limit their height under Portlandia and bottom pruned to provide clearance for adjacent street lights and vehicles. Additional pruning is also likely done for the catenary support cables, branching structure and to clear dead branches. The trees are located approximately half the distance from existing light poles than is recommended by Urban Forestry. As a species, these trees grow quite large. This growth habit, combined with the site constraints, will require them to be aggressively pruned for the remainder of their lives.

To create year-round views of Portlandia and limit long-term maintenance, the two London Planetrees directly in front of Portland Building will need to be removed as part of the reconstruction project. Even with on-going pruning, the two trees will continue to limit views to this important local landmark. The Bureau of Planning and Sustainability's Visual Resources Inventory in the Central City 2035 Plan identifies Portlandia as a View Terminus Focal Point and notes that management of the resource should consider that the street trees while in leaf "almost entirely block" the view. In previous Design Advice Request hearings, the Landmarks Commission has voiced their support for tree removal in this location.

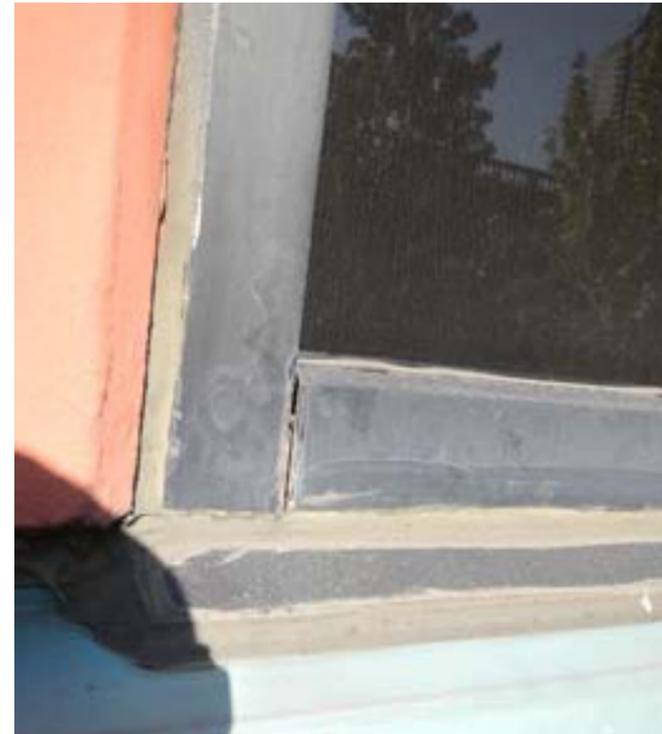
Sealant applied over curtainwall drainage outlet

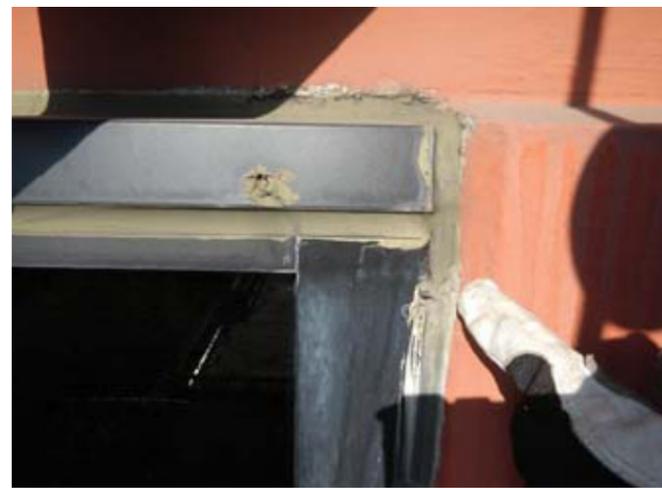
Sealant applied under head flashing

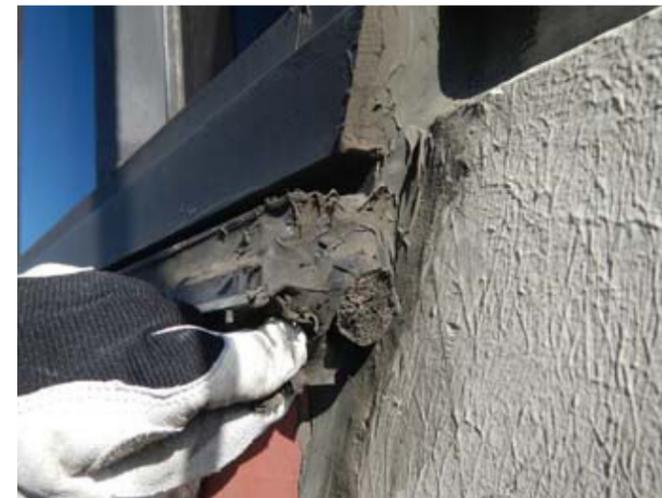
Multiple layers of sealant applications

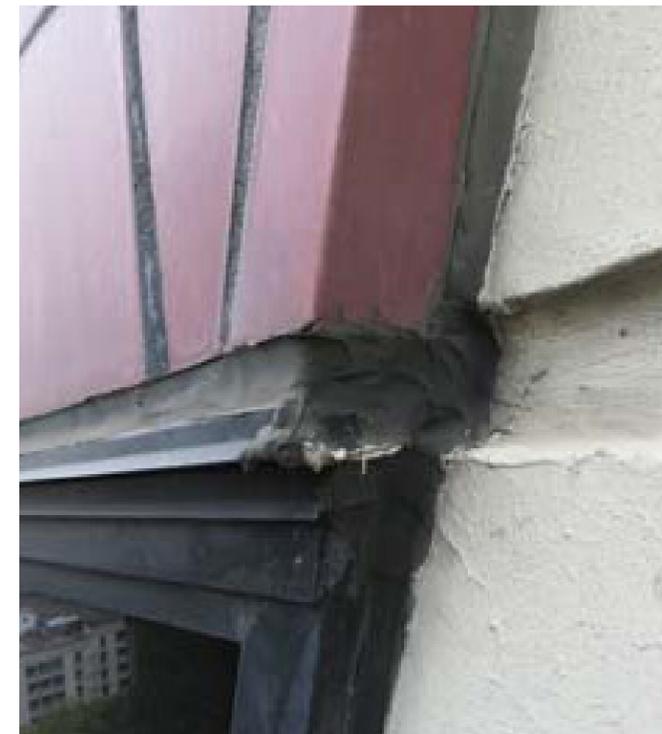
Ribbon window head below reveal

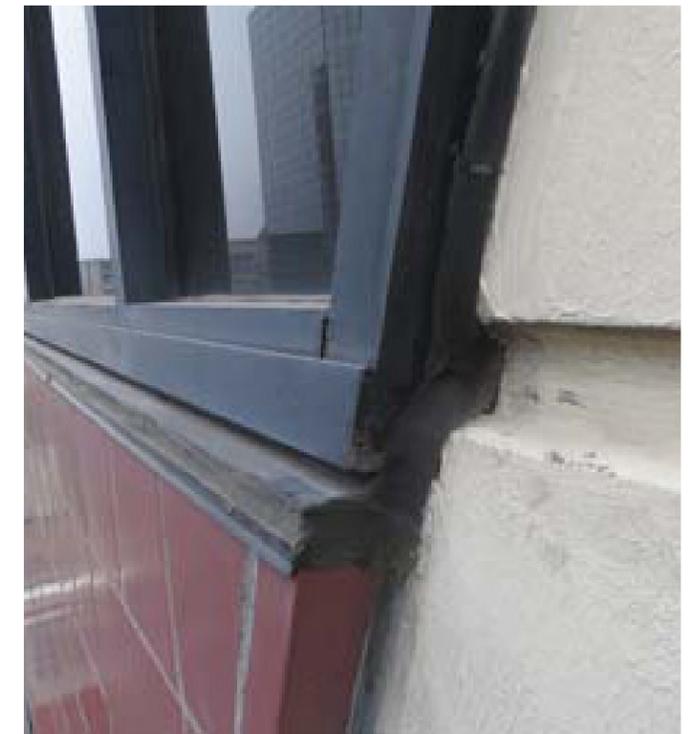
Ribbon window sill aligned with reveal

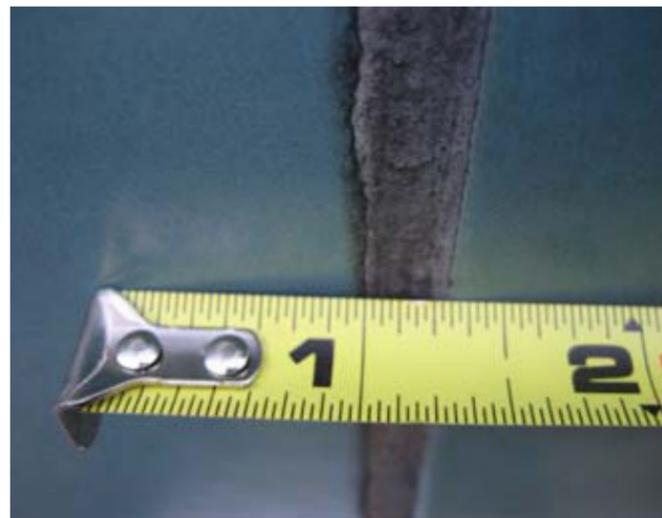
Irregular grout joint size
